Technical Report 15-08

*Experimental Evaluation and Design of
Unfilled and Concrete-Filled FRP
Composite Piles*

*Task 3 - FRP Composite Pile Flexural
Testing*

FRP Composite Pile Flexural Testing

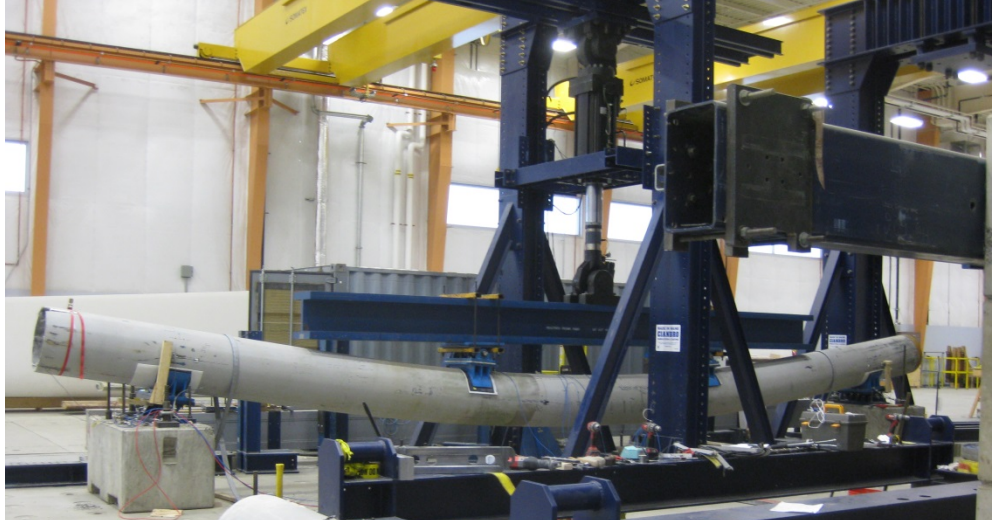
Figure 1: Flexural Test Configuration

All piles were tested in a four-point bending configuration that can be seen in Figure 1. The span length for each test was 33 feet. The load was applied using a single 300 kip actuator with a spreader beam. Load points were at the 1/3 points of the span (11 feet), except for Pile C when load points were adjusted to create higher moments.

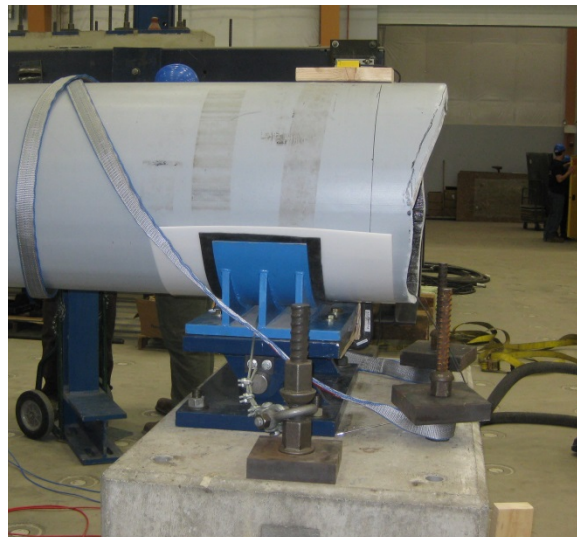
Figure 2: Saddle and Support Configuration

Saddles with a curvature equal to that of the piles were used at loading points and end supports to distribute load over the pile. Each saddle was lined with neoprene to aid in load distribution and a plastic sheet to allow lateral translation. These saddles were mounted on pinned supports that allowed rotations associated with the large expected deflections. A saddle and pinned support can be seen in Figure 2.

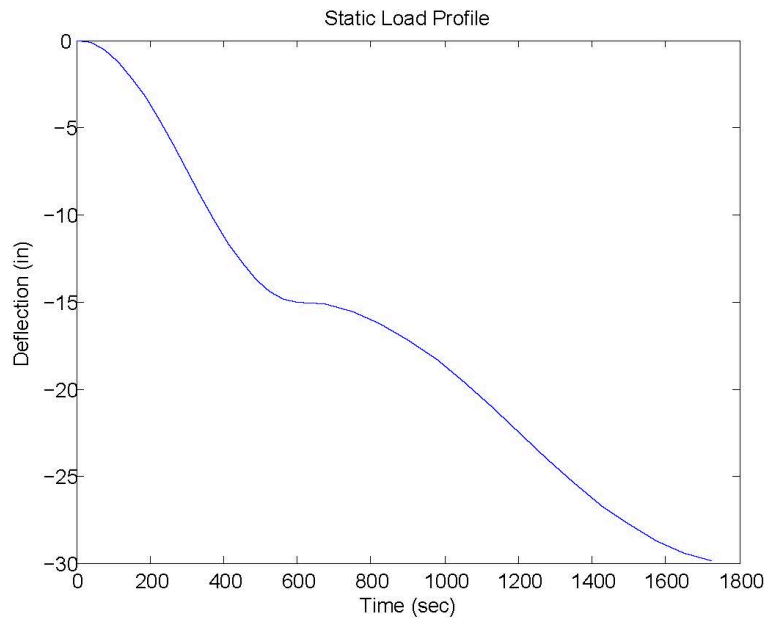
Figure 3: Static Loading Profile

Static piles were loaded to failure by controlling the rate of displacement. Piles were loaded at a rate of 1.5 inches per minute for the first 15 inches of deflection. Then the loading rate was

transitioned to 1 inch per minute using a sinusoidal ramp. A plot of the loading profile can be seen in Figure 3.

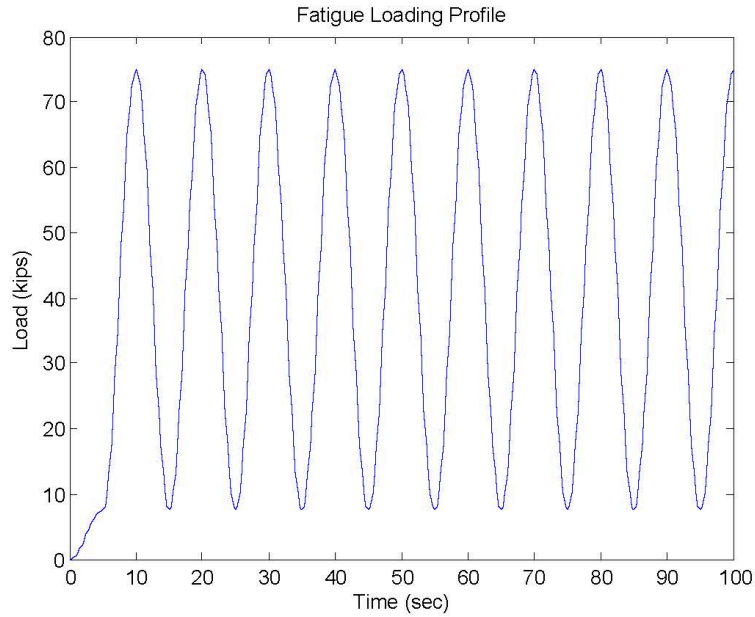
Figure 4: Cyclic Loading Profile

Load-cycled piles were loaded to 50 percent of the average ultimate load of the previously tested piles. This load was determined to be 75 kips. The piles were cycled between 7.5 kips and 75 kips for 10,000 cycles at a frequency of 0.05 Hz. After 10,000 cycles, the piles were rotated 180 degrees about their longitudinal axis and subjected to an additional 10,000 cycles. Then, the piles were tested statically to failure. Strain and displacement measurements were taken at the maximum and minimum load of each cycle. Data was collected over the entire loading cycle for 10 cycles every 1,000 cycles. A plot of the loading profile can be seen in Figure 4.

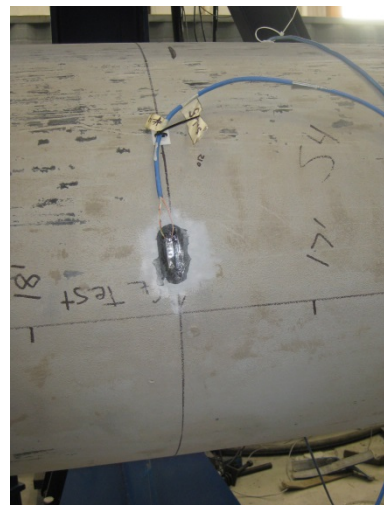
Figure 6: Typical Hoop Strain Gage

All piles were instrumented with 2 sets of 3 strain gages oriented in the longitudinal direction of the pile. Each set of strain gages has 1 gage at the extreme tension fiber (Strain 1 & 5), 1 gage at the mid-height of the cross section (Strain 2 & 6), and 1 gage at the extreme compression fiber (Strain 3 & 7). This can be seen in Figure 5. An additional strain gage was oriented in the hoop direction (Strain 4) at the midspan of the pile. This can be seen in Figure 6.

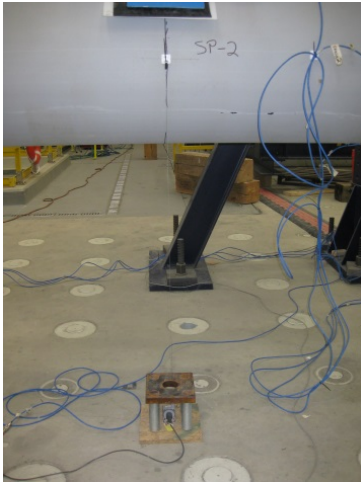
Figure 7: Vertical Deflection Measurement

Deflections were measured at the mid-point of the span (SP-3) and both loading points (SP-2 & 4) using Celesco SP2-50 sting potentiometers (string pots). This can be seen in Figure 7. Lateral translations were measured at each support using Celesco SP2-25 string pots (SP-1 & 5). This can be seen in Figure 8. All measurements were taken at the mid-height of the cross section.

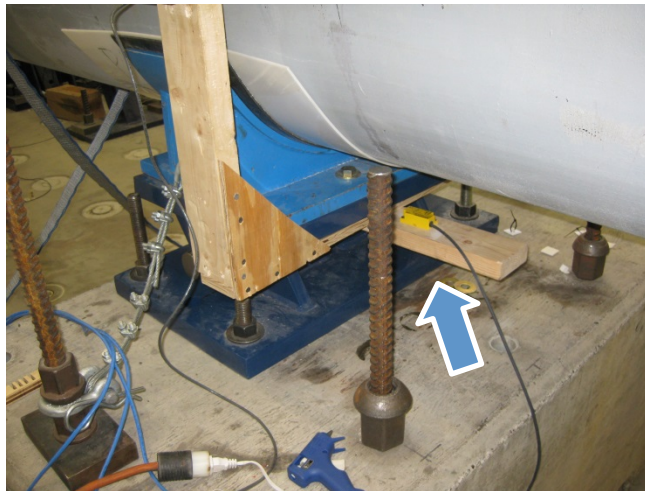
Figure 9: Longitudinal Rotation Measurement

Axial rotation was measured at each pinned end support using +/- 60-degree TURK B2N60H-Q20L60-2LU3/S97 inclinometers (Inc-100 & 200). This can be seen in Figure 9.

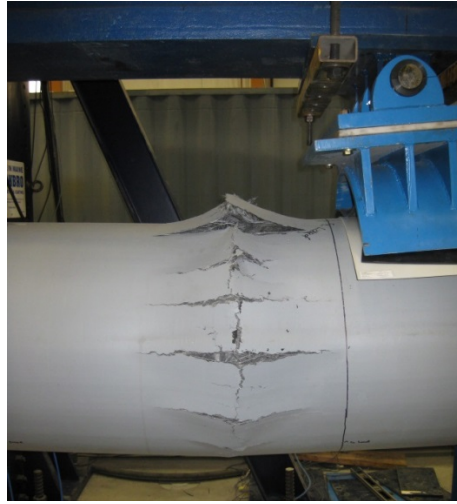
Figure 12: Compression Failure of Pile I-8HB

Pile I failed by compression at a load of 122 kips, and a corresponding moment of 673 kip*ft. It is believed that the layers of E-glass reinforcement delaminated, and then buckled locally. The

failure occurred approximately 1 foot from the nearest loading point (inside the constant moment region) and can be seen in Figure 12.

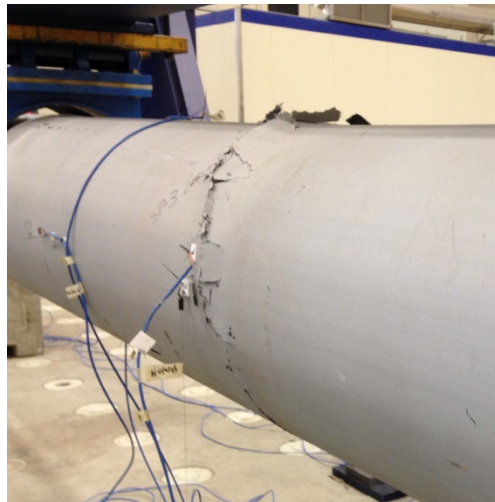
Figure 13: Compression Failure of Pile J-8HB

Pile J failed by compression at a load of 90 kips and a corresponding moment of 492 kip*ft. It is believed that the layers of E-glass reinforcement delaminated, and then buckled locally. The failure occurred at the midspan of the pile and can be seen in Figure 13.

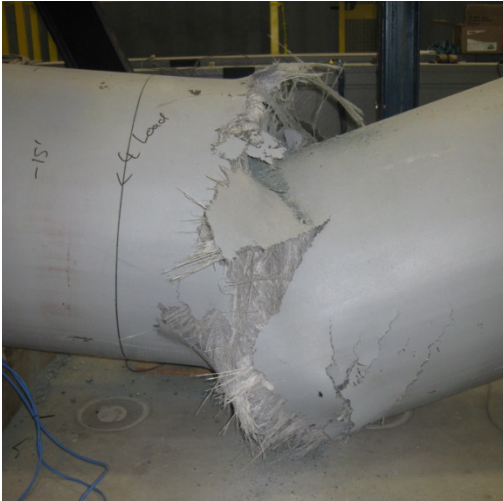
Figure 21: Tension Failure of Pile G-4FB

Pile G failed at a load of 200 kips and a corresponding moment of 1,099 kip*ft. when fibers on the tension face appeared to rupture. The failure occurred approximately 1 foot from the nearest loading point (outside the constant moment region) and can be seen in Figure 21, and Figure 22.

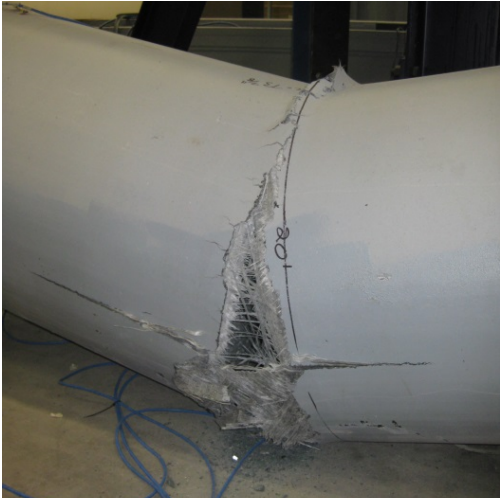
Figure 23: Tension Failure of Pile H-4FB

Pile H failed at a load of 119 kips and a corresponding moment of 652 kip*ft. when fibers on the tension face appeared to rupture. The failure occurred at the midspan of the pile and can be seen in Figure 23, and Figure 24.

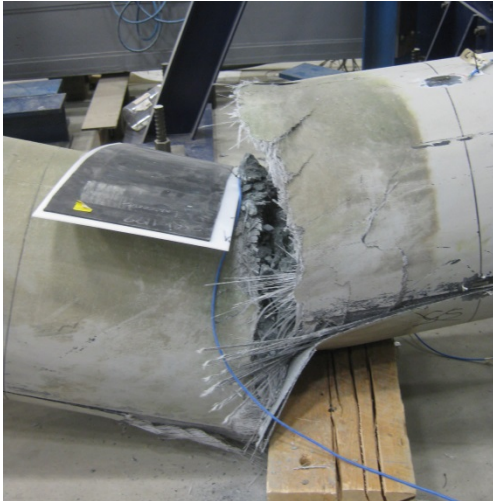
Figure 25: Tension Failure of Pile A-4FB

Pile A failed at a load of 174 kips and a corresponding moment of 958 kip*ft. when fibers on the tension face appeared to rupture. The failure occurred approximately 2 feet from the nearest loading point (inside the constant moment region) and can be seen in Figure 25, and Figure 26.

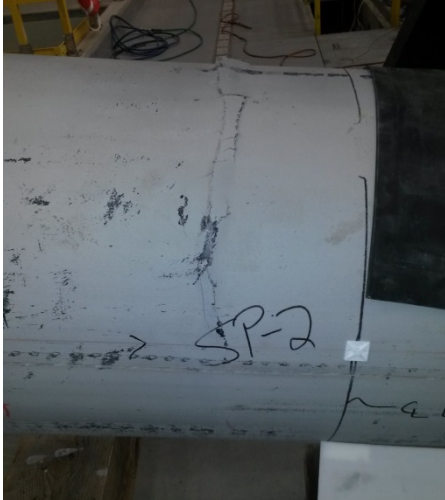
Figure 27: Compression Wrinkle

A compression wrinkle developed outside of the constant moment region at an approximate load of 155 kips and corresponding moment of 853 kip*ft. The compression wrinkle can be seen in Figure 27. After testing, the FRP shell was cut at the compression wrinkle and a crack that goes through the entire cross section of concrete was discovered. It is believed that this crack occurred during driving. The crack can be seen in Figure 28.

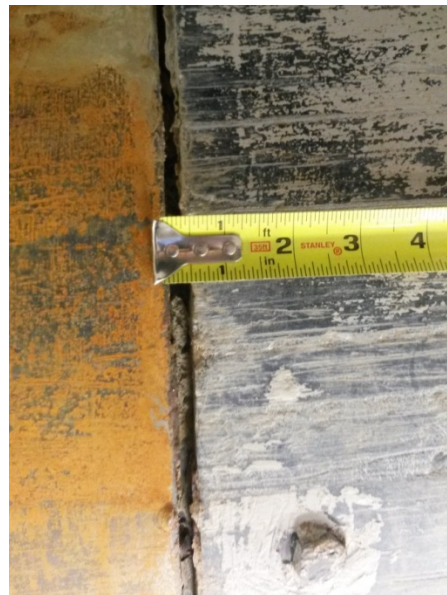
Figure 29: Loss of Composite Action in Pile A

When this compression wrinkle occurred, the concrete moved with respect to the shell of the pile. The concrete displacement measurement during the test was unreliable, but the concrete displacement measured after the test was 0.245 inches at the end of the pile. The movement at the end of the pile can be seen in Figure 29.

Pile A and C both lost composite action during flexural testing. These were the only piles driven while filled with concrete. Pile A was filled with concrete prior to initial driving and was not restruck. Pile C was initially driven hollow then filled with concrete prior to being restruck. It is believed that tensile forces during driving caused cracking in the concrete, which created a failure plane for the concrete to slide at. It is also possible that cracks through the cross section of Pile C are the result of rotating the pile 90 degrees for its third test.

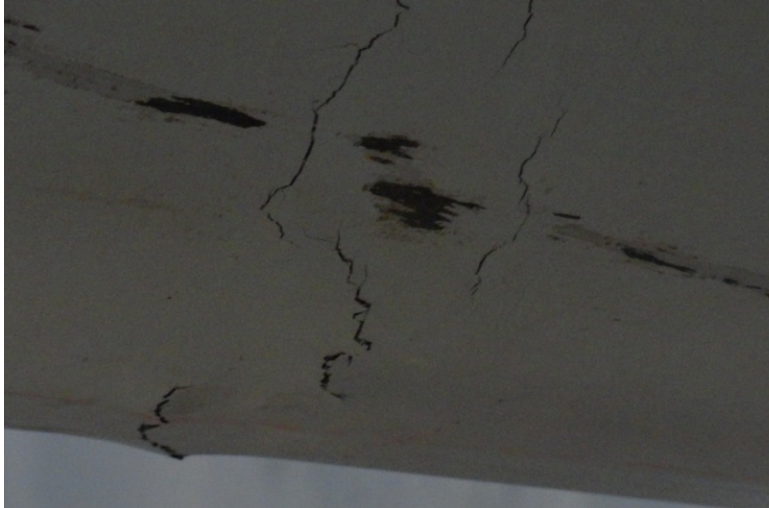
Figure 30: Cracks Due to Cyclic Loading

Pile E was cycled according to the procedure described in 4.2. During cyclic loading, Pile E developed small cracks along the tension face. These cracks can be seen in Figure 30.

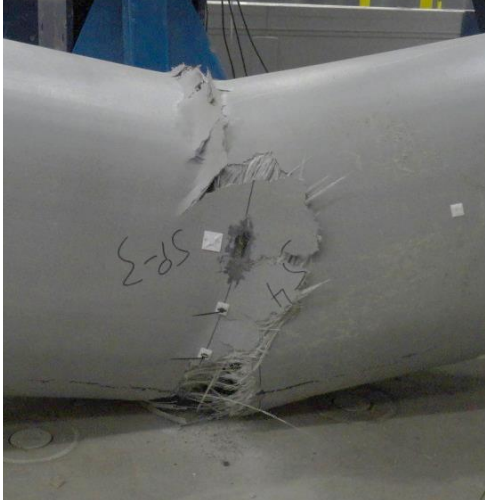
Figure 31: Tension Failure of Pile E-4FB

During the static test to failure after cyclic loading, Pile E initially showed a compression failure at 158 kips and the load dropped to 149 kips. The load started to rise again to 158 kips and a corresponding moment of 871 kip*ft. where the pile appeared to fail in tension. The failure occurred at the midspan of the pile and can be seen in Figure 31 and Figure 32.

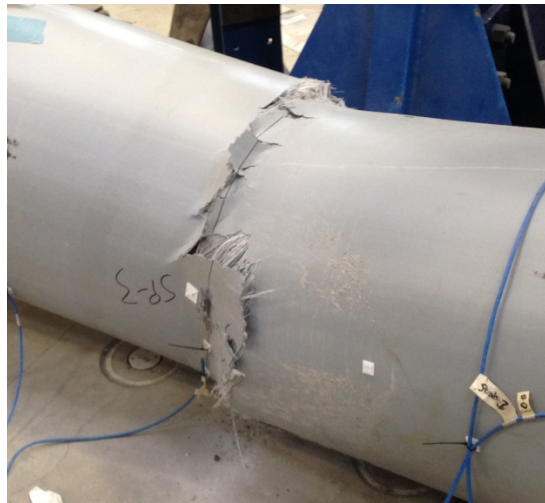
Figure 33: Tension Failure of Pile F-4FB

Pile F was cycled according to the procedure described in 4.2. During the static test to failure after cyclic loading, Pile F failed at a load of 127 kips and a corresponding moment of 699 kip*ft. when fibers on the tension face appeared to rupture. The failure occurred at the midspan of the pile and can be seen in Figure 33.

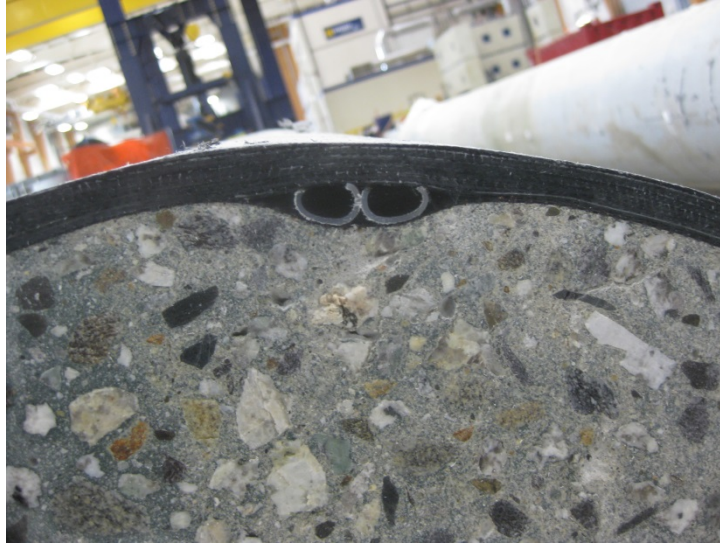
Figure 36: Concrete-FRP Interface

Concrete-filled piles were cut for disposal after testing. The cut piles showed no significant gaps between the concrete and FRP shell. It should be noted that MDOT Class A concrete with no expansive additive was used to fill the piles. A typical cut can be seen in Figure 36.

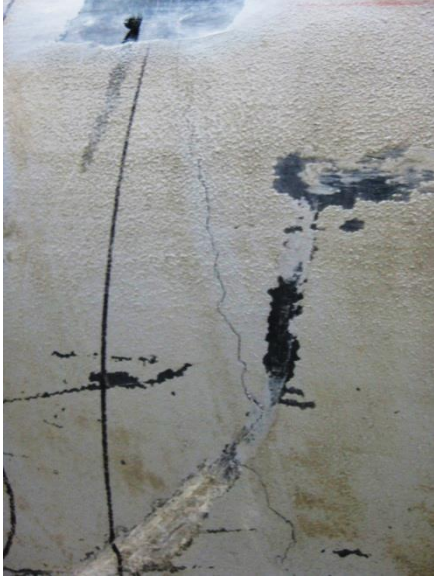
Figure 37: Cracks in Constant Moment Region

The first test of Pile C went to the capacity of the test setup. The load cell reached its capacity at an applied load of 300 kips and corresponding moment of 1650 kip*ft., ending the test. The pile developed a series of hairline cracks along the tension face at two points: 2.5 feet from the nearest load point (inside the constant moment region) and 3.5 feet from the nearest load point (outside the constant moment region). These cracks can be seen in Figure 37, and Figure 38.

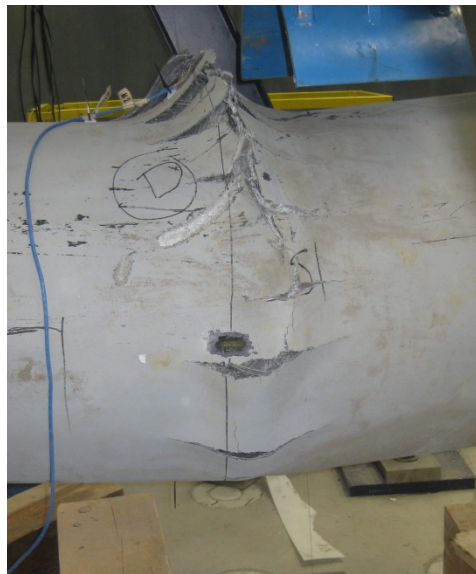
Figure 40: Compression Failure of Pile C-8HFB

Pile C failed by compression at a load of 263 kips and a corresponding moment of 1,710 kip*ft. The pile was able to fail in compression because the concrete slid relative to the FRP shell, creating a void in the pile at failure. The failure can be seen in Figure 40.

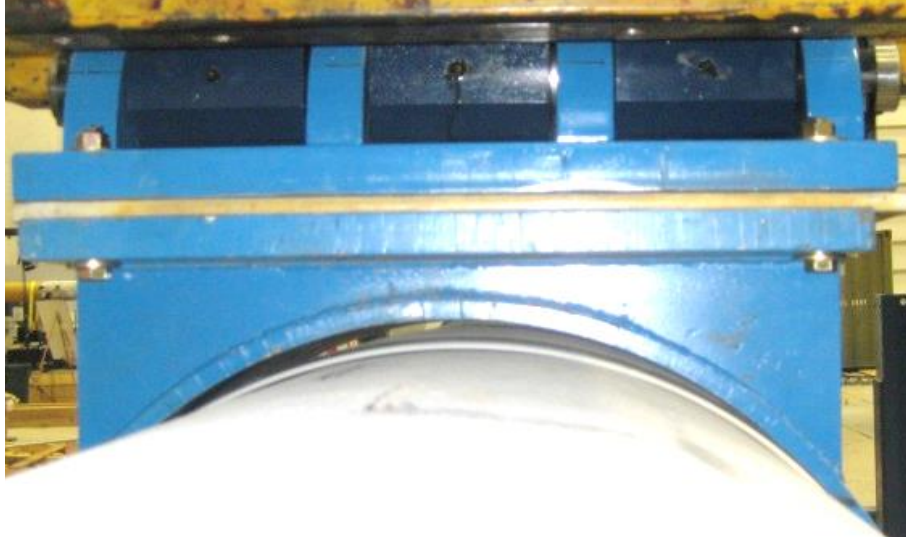
Figure 50: Variation in Roundness of Piles

A variation in the roundness of the piles will affect the load distribution on the pile and create local areas of high stress under the load head. This variation in roundness was seen in hollow and concrete-filled piles, but it is believed that hollow piles were able to conform to the load heads, which distributed the applied load better. Hollow piles saw ovalizations up to 0.5 inches (Pile I). An example of variation in the roundness of piles can be seen in Figure 50.

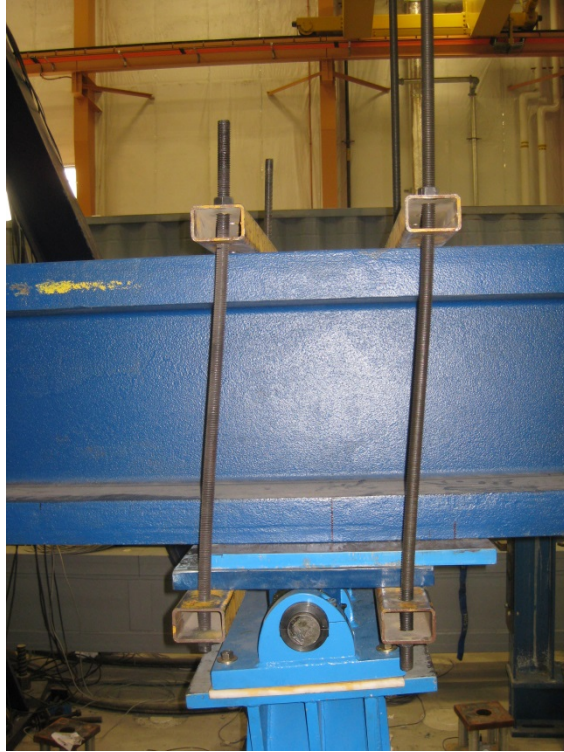
Figure 51: Movement of Saddle at Loading Point After Failure

Saddles at loading points shifted during some tests. This may have caused more loads to apply to one side of the pile. Saddles did not move more than approximately 2 inches during any test. A large portion of this saddle movement may have occurred when the piles failed and contacted the spreader beam. It is not believed that this caused a significant effect due to the relatively large span length (33 feet). The saddle movement can be seen in Figure 51.
