Technical Report GL-94-1  
January 1994

# In Situ Geophysical Investigation of the Pile Test Section, Sardis Dam, Mississippi

by José L. Llopis  
Geotechnical Laboratory

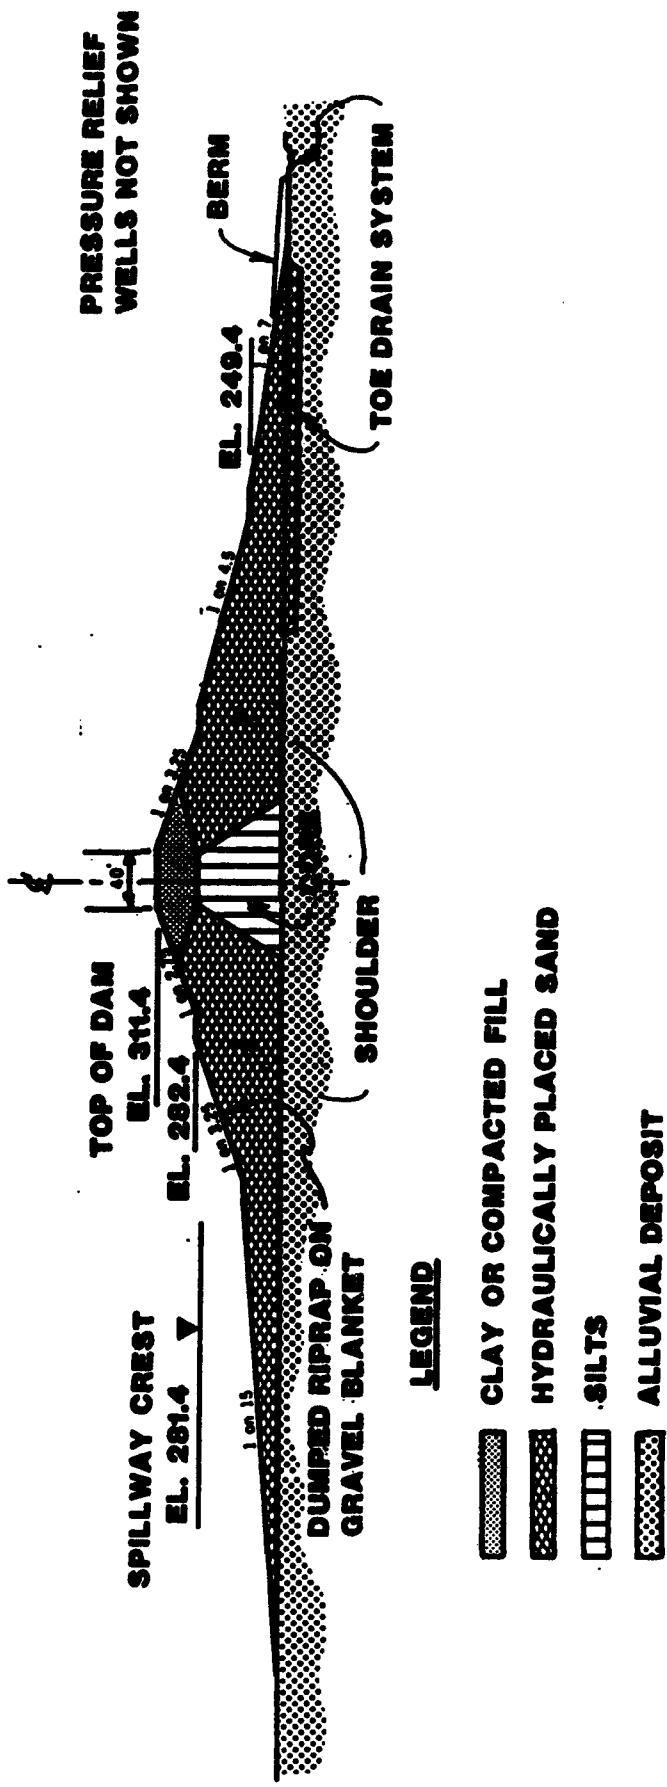
Figure 2. Typical section of Sardis Dam

The dam is composed of a main embankment, abutment dikes, spillway, and outlet works. The main dam has an approximate length of 8500 ft. The crown width is approximately 40 ft. wide at the dam crest. The maximum height of the dam above the streambed is 117 ft. (U.S. Army 1985). Figure 2 shows a typical cross section of the dam.

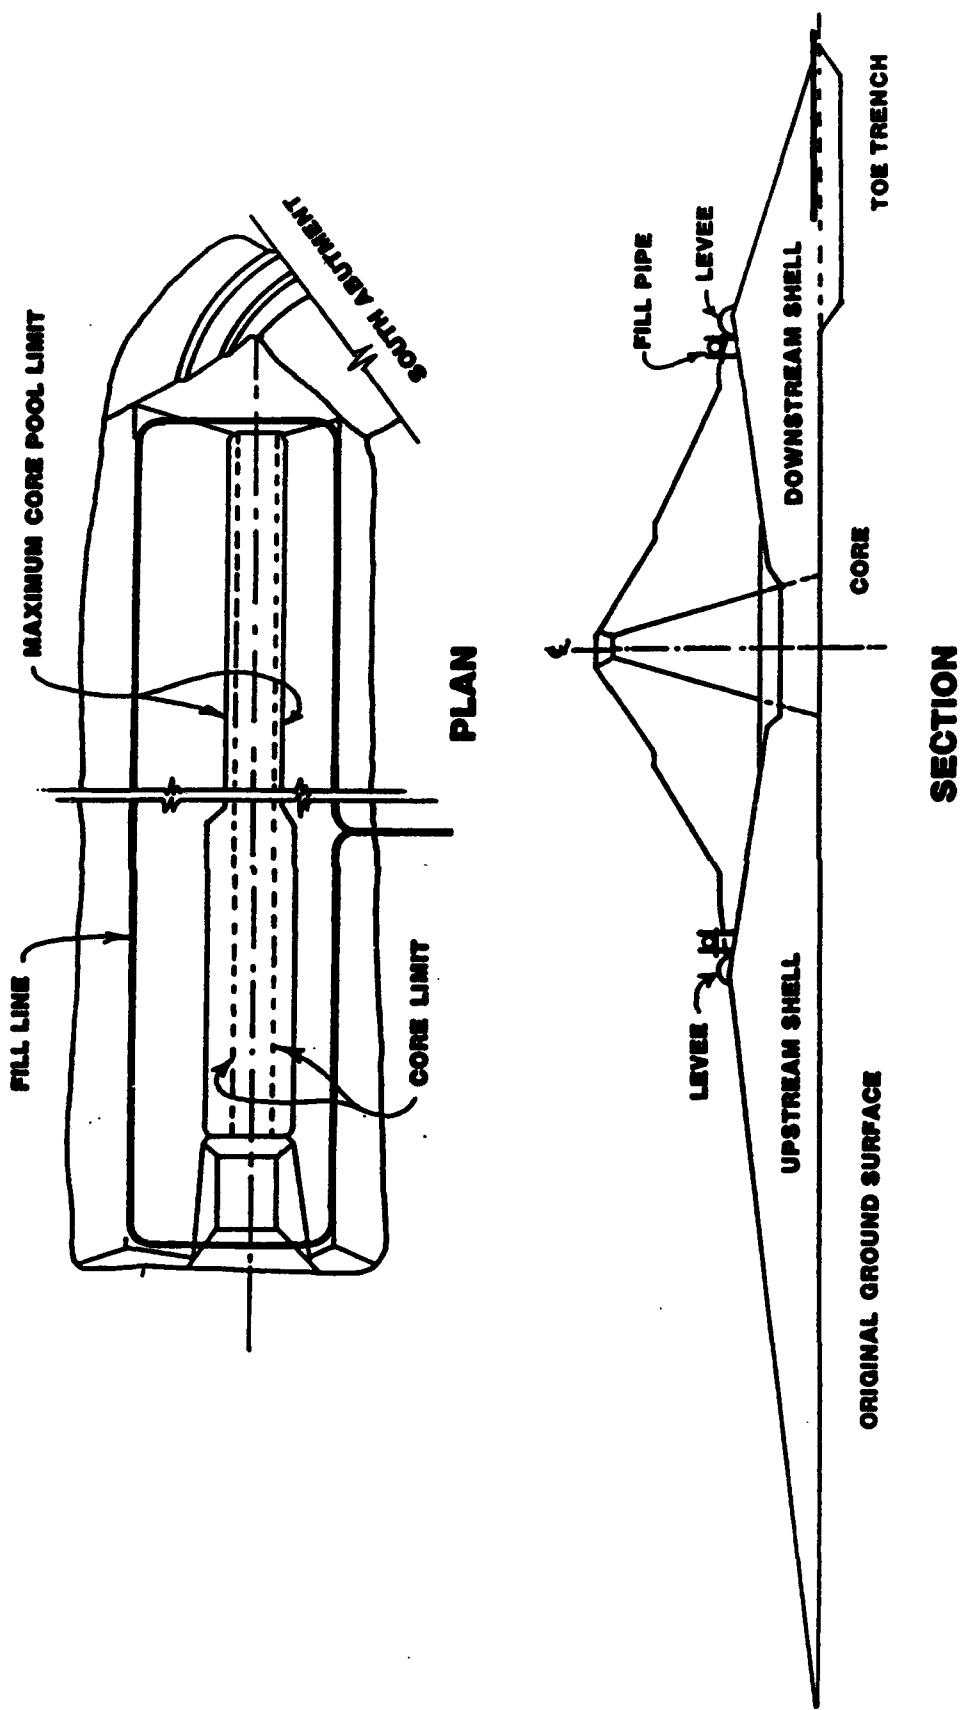
Figure 3. Hydraulic fill placement

Sardis dam is a hydraulically placed embankment consisting of a fine grained central core and two flanking sand shells. The construction method that was used is demonstrated in Figure 3. Material from a nearby borrow area was pumped into the zone between the downstream and upstream shells. The finer grained material (mostly silt) flowed toward the center and formed the central core whereas, the coarser material was deposited near the fill pipe and formed the shells. The colloidal fraction of the effluent was drained off to a disposal area (U.S. Army 1985).

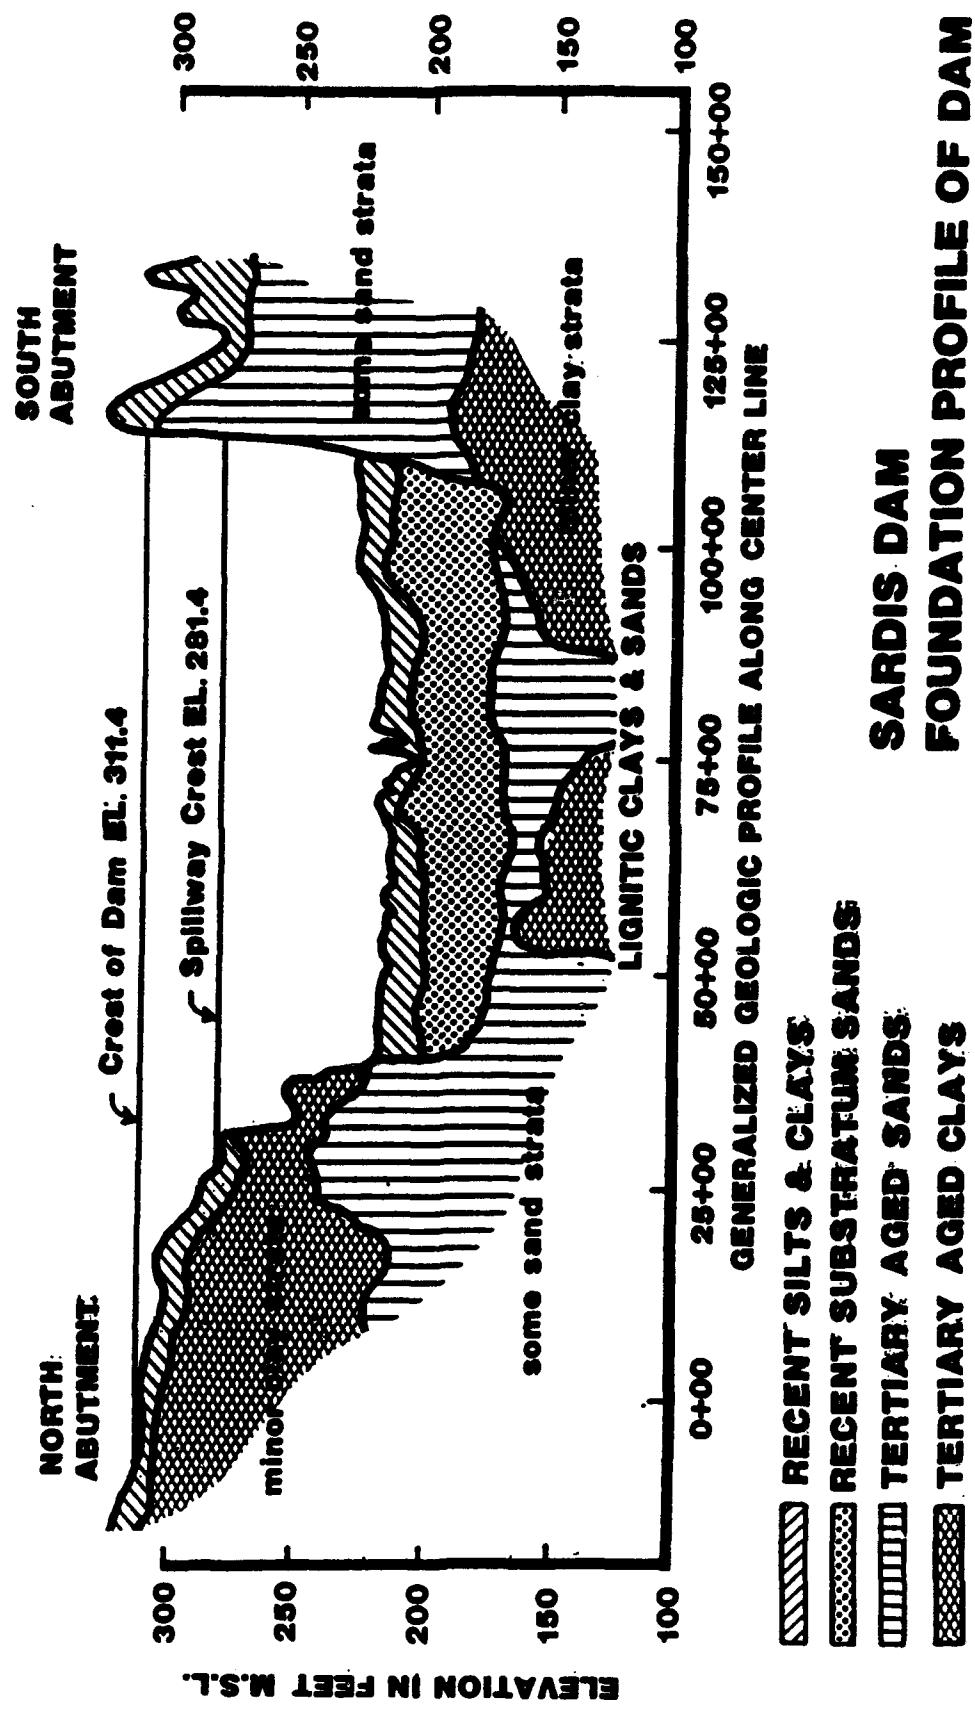
Figure 4. Foundation profile of Sardis Dam

The dam's foundation consists of Recent and Tertiary aged deposits. A generalized geologic profile is shown in Figure 4. The foundation has a 10 to 20-ft thick zone of natural silty clay, designated as the topstratum clay in Figure 4 and extends 1200 ft upstream of the dam centerline. In areas of the original streambed the topstratum clay was nonexistent and a 10-ft thick silty

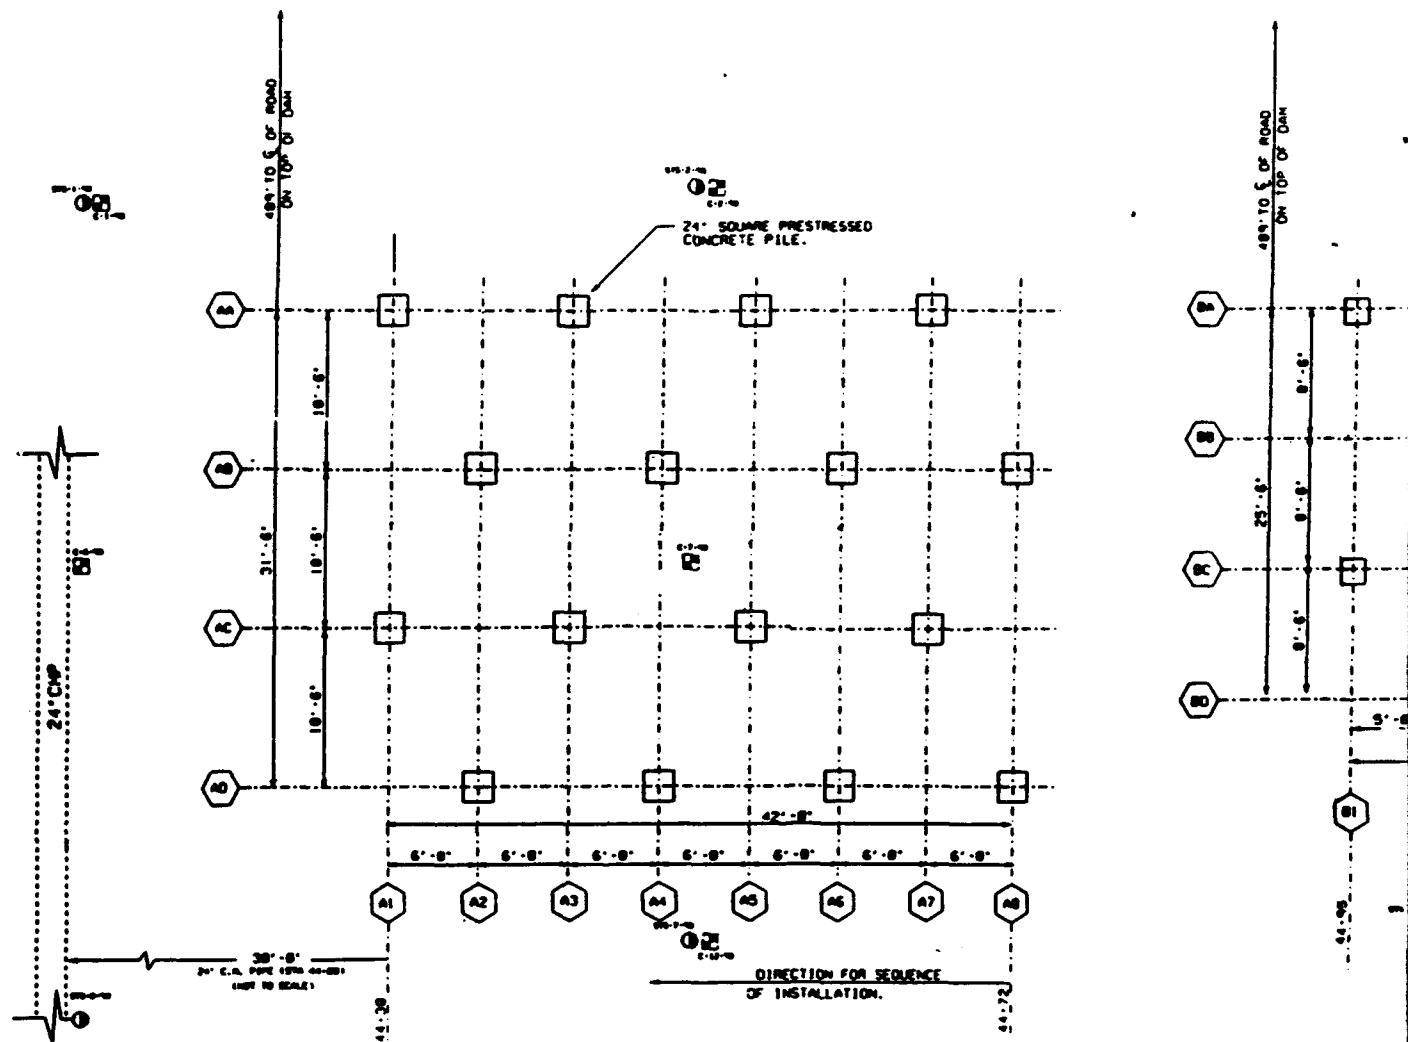
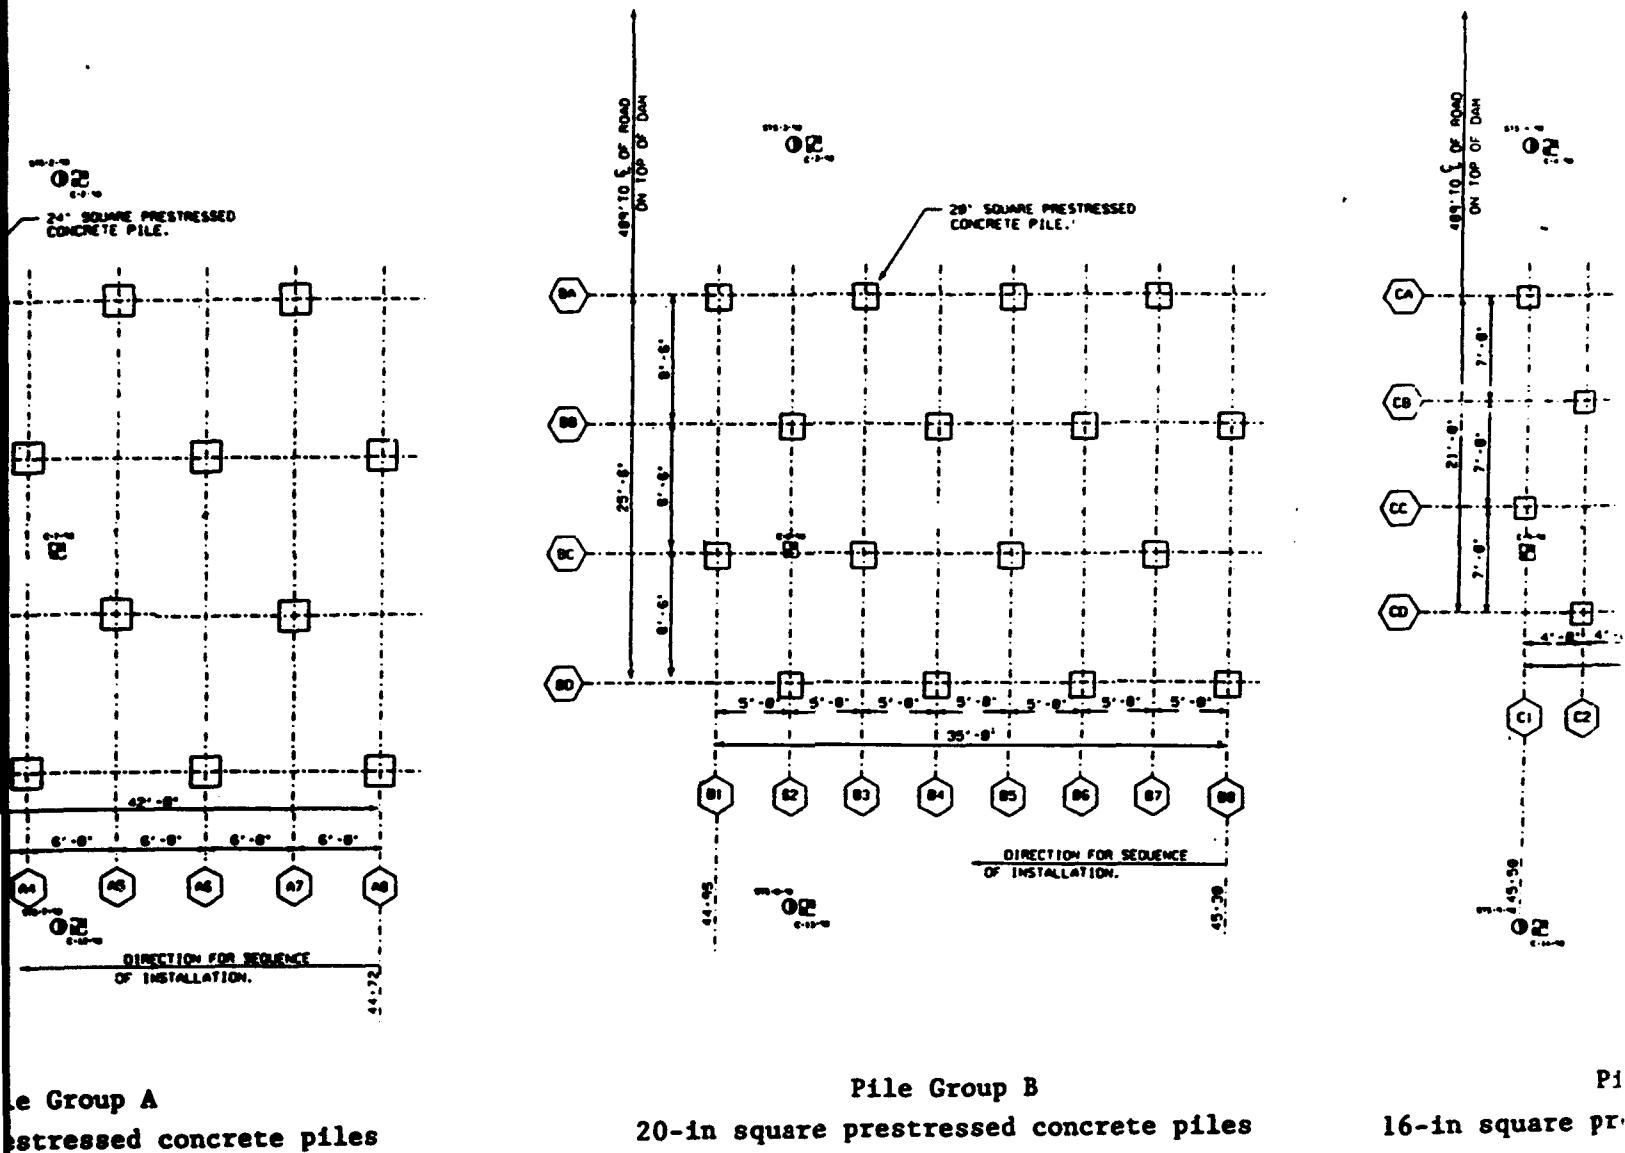
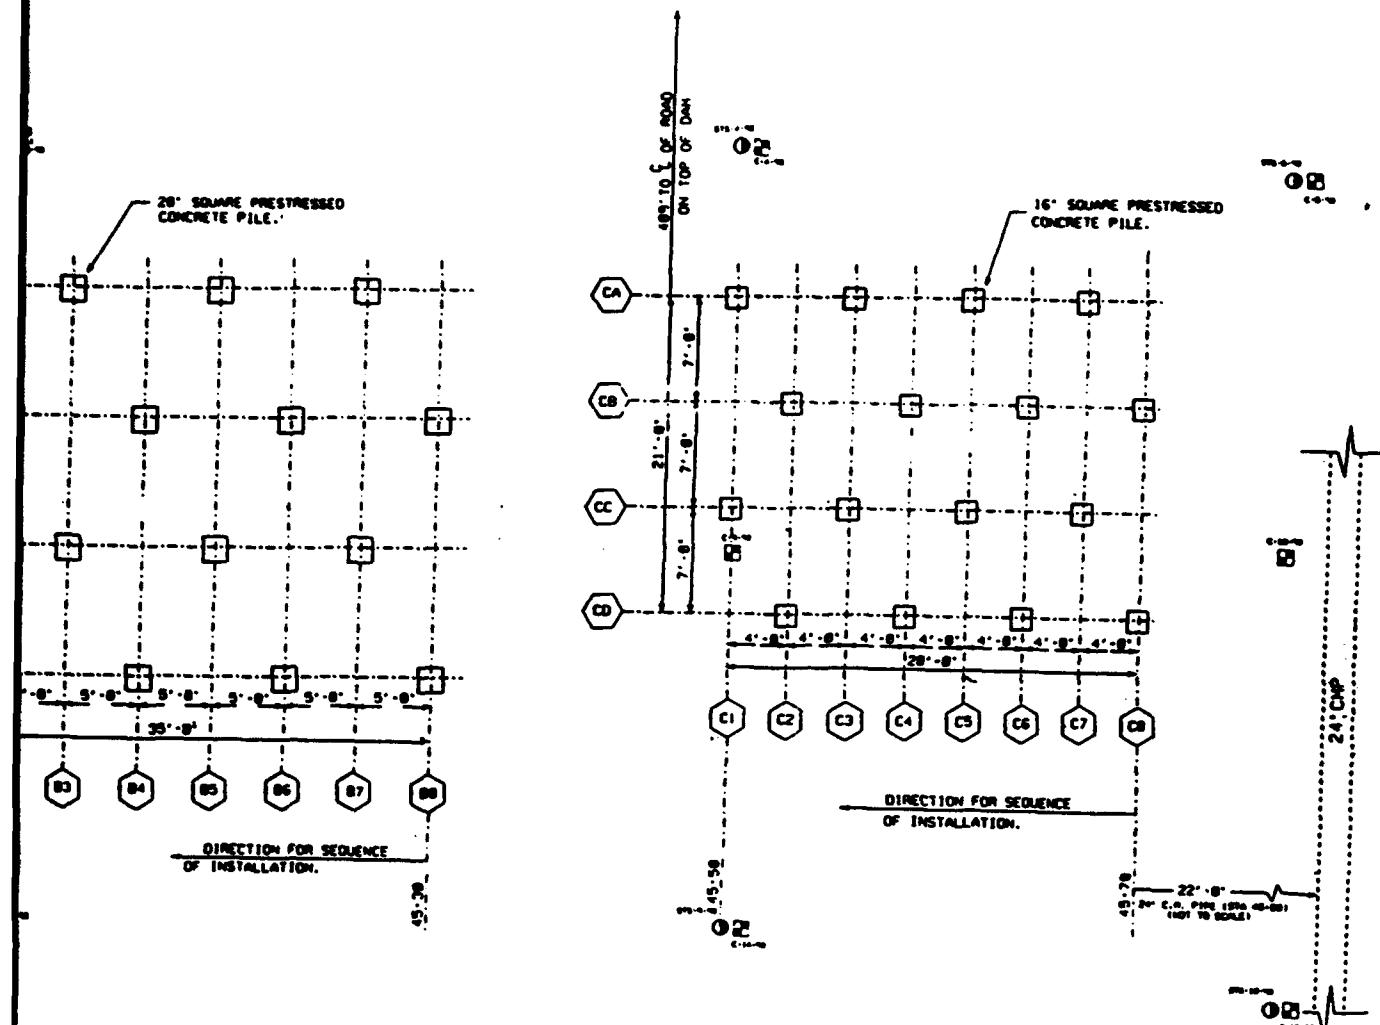
Figure 6. Location and layout of pile groups A, B, and C

The main pile test section, located between Sta. 44+30 and 45+78, was divided into 3 test sections referred to as Pile Groups A, B and C (Figure 6). Square, 24-, 20-, and 16-in prestressed concrete piles were driven into Pile Groups A, B, and C, respectively. Spacings between piles for each pile group and the pile driving pattern are shown in Figure 6. The piles were 55 ft in length and were driven such that the tops of the piles were slightly below the ground surface. The pile tips were driven slightly into the Tertiary materials (tip elevation approximately 168 ft).

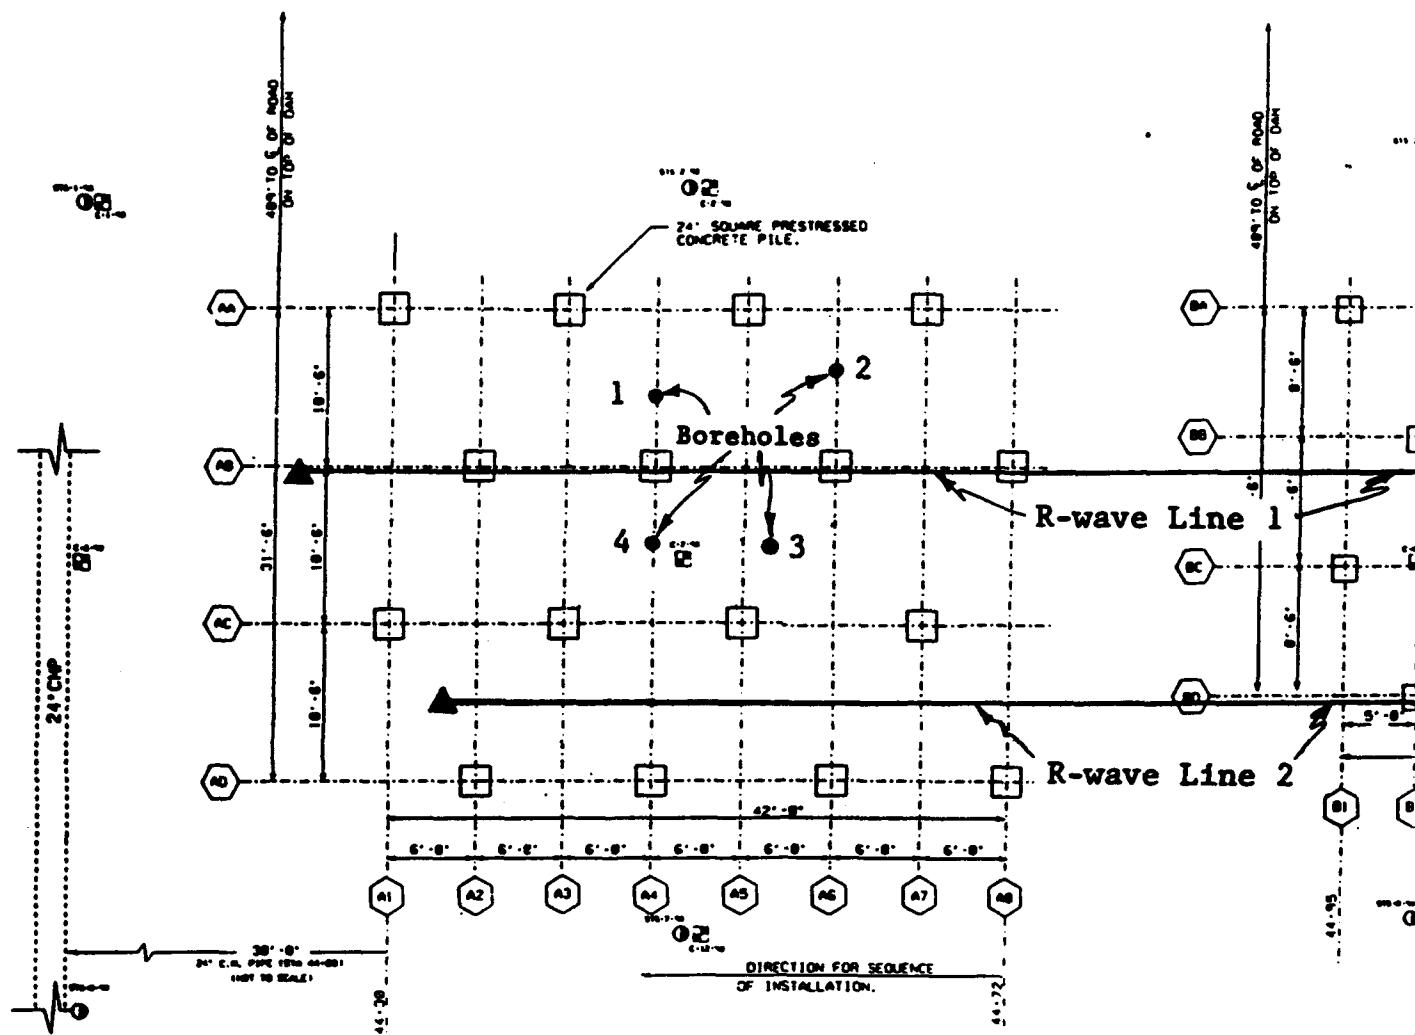
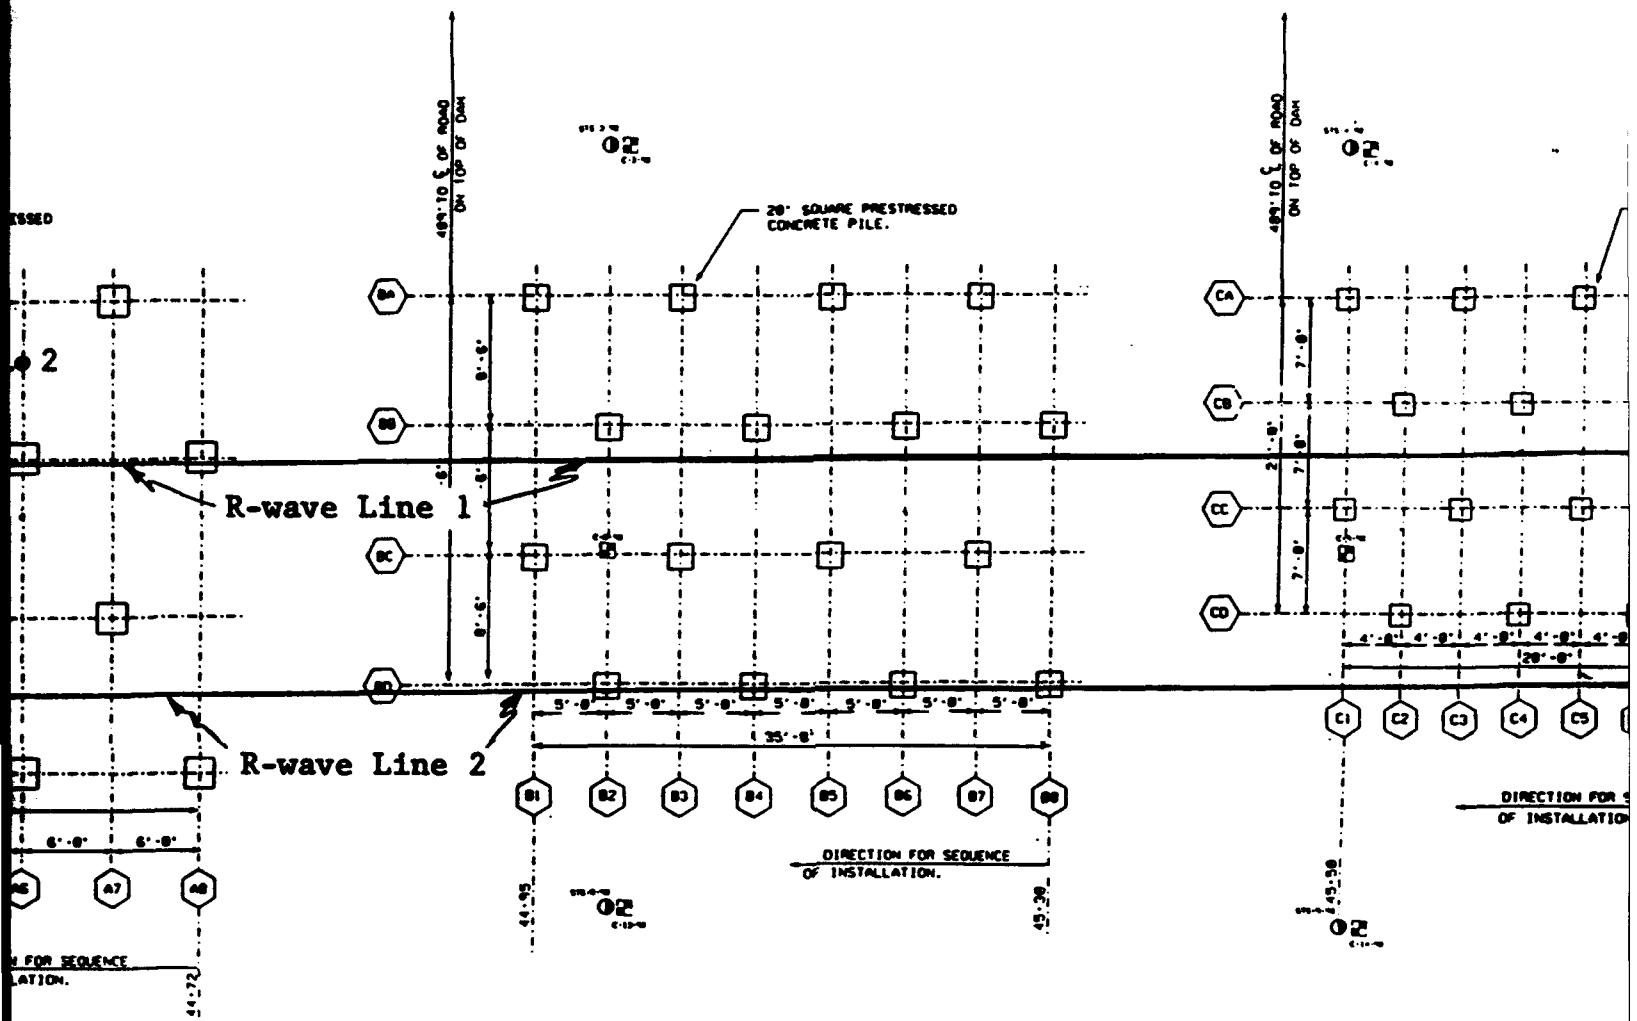
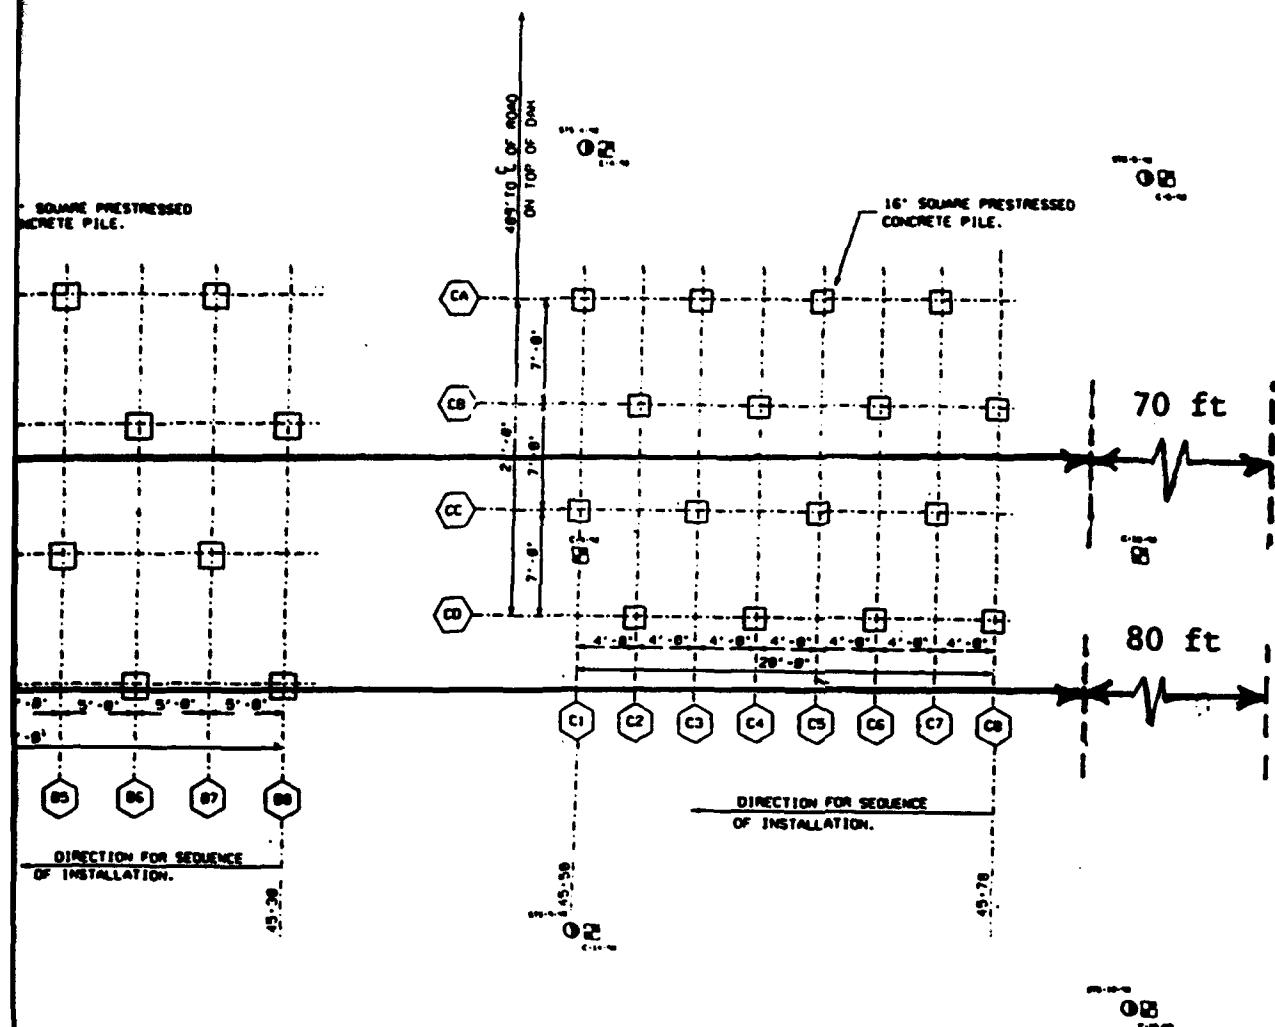
Figure 7. Location and layout of geophysical tests

Crosshole tests were run to determine horizontal S-wave velocities as a function of depth. The location of the four borings used for crosshole testing are shown in Figure 7. An advantage of the crosshole test as opposed to surface seismic refraction test is its ability to detect low velocity layers underlying or sandwiched between layers of higher velocity. One shortcoming of the crosshole method is that boreholes are required for testing. Thus, crosshole tests seismic tests are more costly than a surface seismic refraction test. However, the crosshole technique is considered to be more definitive and accurate than the surface seismic refraction test for measuring S-wave velocities. Basically, the testing consists of measuring the arrival time of an S-wave that has traveled from a source in one borehole to a detector in another borehole at the same elevation. This procedure is then repeated for the next test elevation. Knowing the distance between borings and the time the S-waves take to travel across this distance the velocity can be computed (distance divided by time).

The location and layout of the two surface vibratory tests run at the site are shown in Figure 7. These tests were conducted to determine the Rayleigh-wave (R-wave) velocity of the materials comprising the three pile groups and a region outside the test area (baseline). The R-wave velocity is slightly lower than the S-wave velocity, in fact for homogeneous media and for Poisson's ratios commonly found in soil materials, the difference in velocities is less than 9 percent (Ballard 1964 and Vrettos and Prange 1990).

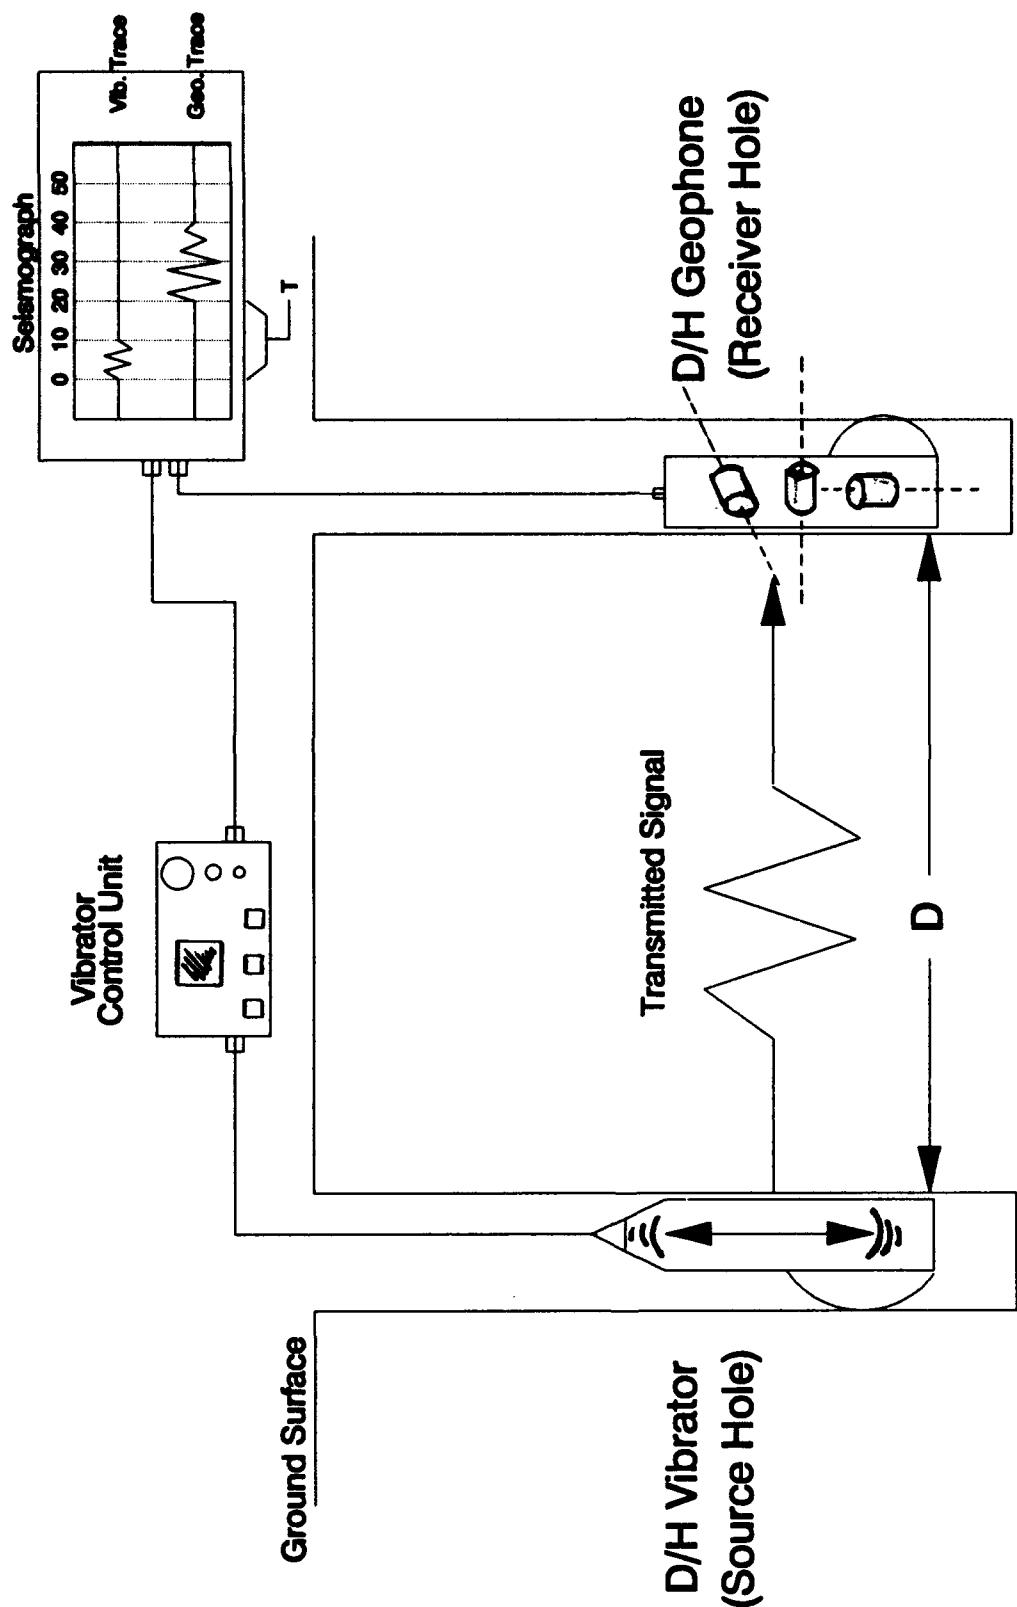
Figure 9. Crosshole S-wave testing setup

S-wave velocities were obtained by placing an S-wave source in a source hole and detectors, at the same elevation, in two other boreholes (receiver holes). The detectors consisted of a triaxial array of geophones (two mounted horizontally at 90 deg. to each other, and one vertically oriented) in one container. The container housing the geophones was clamped firmly to the casing wall by means of an expanding pneumatic piston. A downhole vibrator was used as a source of S-waves. The S-wave testing procedure consisted of lowering the vibrator in the borehole to a selected test elevation and clamping the vibrator firmly to the sidewalls of casing by means of an inflatable rubber bladder. When the vibrator was in position, the operator tested a range of frequencies (50 to 250 Hz) and selected one that propagated well (one with a high amplitude) through the transmitting medium. The time required for the S-wave to travel from source to receiver hole was recorded using a portable, 24 channel seismograph with data-enhancement capability. Figure 9 illustrates the crosshole S-wave technique.

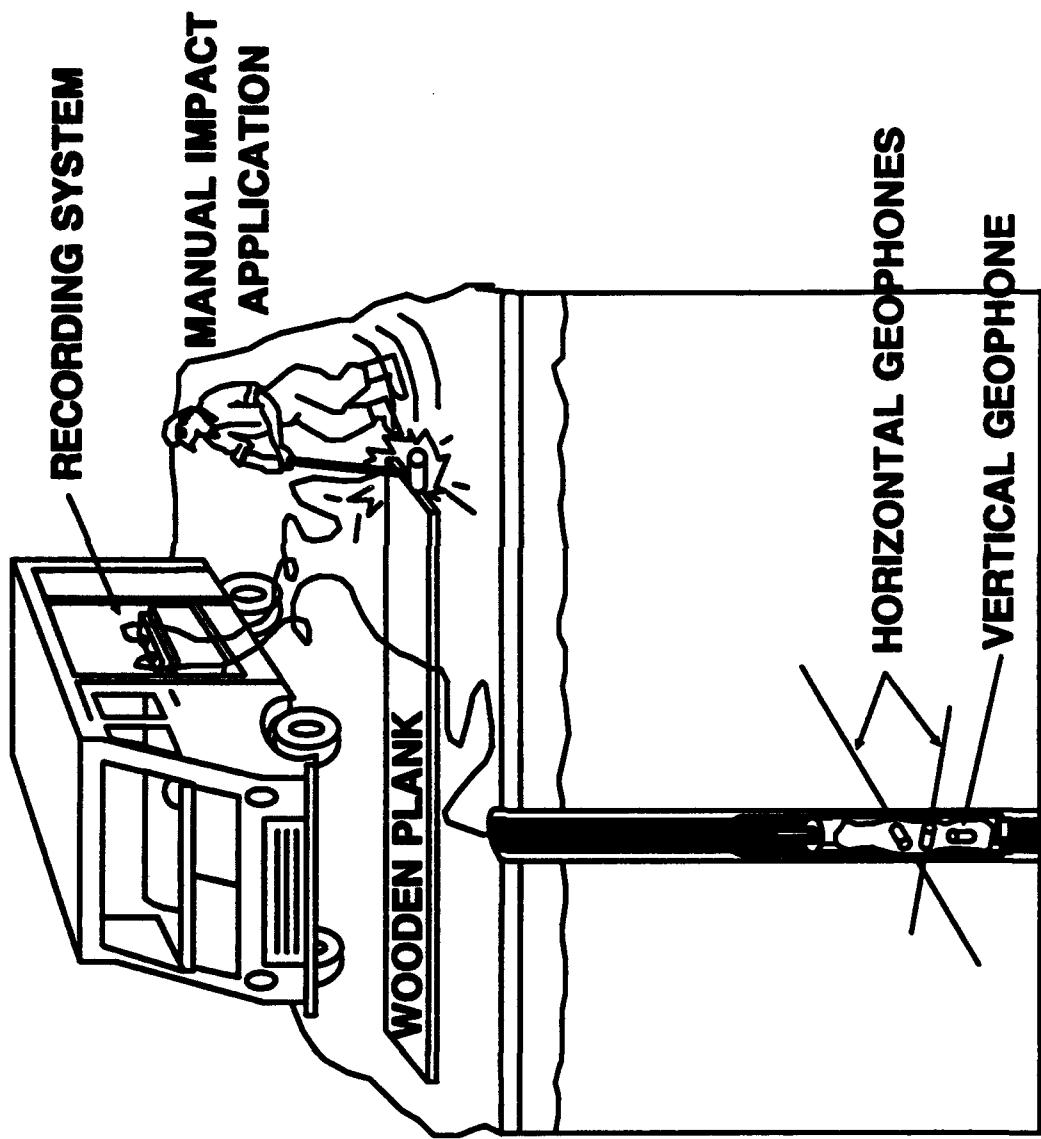
Figure 10. Downhole S-wave testing setup

Downhole tests were conducted by placing an S-wave energy source on the ground surface close to the mouth of a borehole, and a triaxial array of geophones placed in the borehole. In this type of survey the travel path of seismic signal is forced to traverse all of the strata between the source and detector. The downhole test also has the ability to detect inversion layers and therefore, complements the crosshole test. An illustration of the downhole S-wave technique is shown in Figure 10.

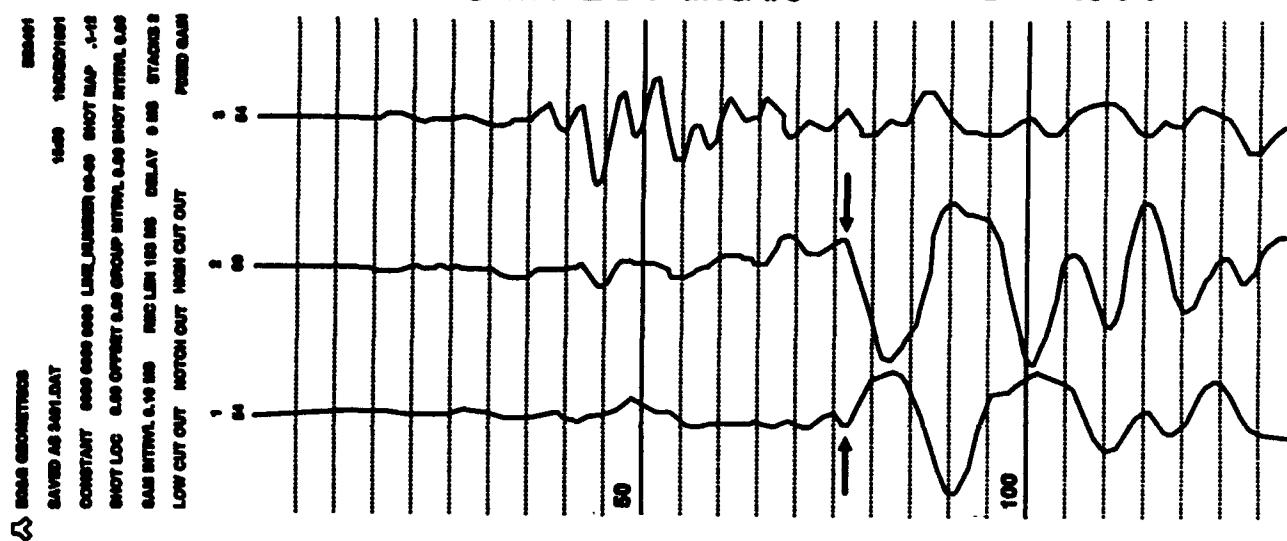
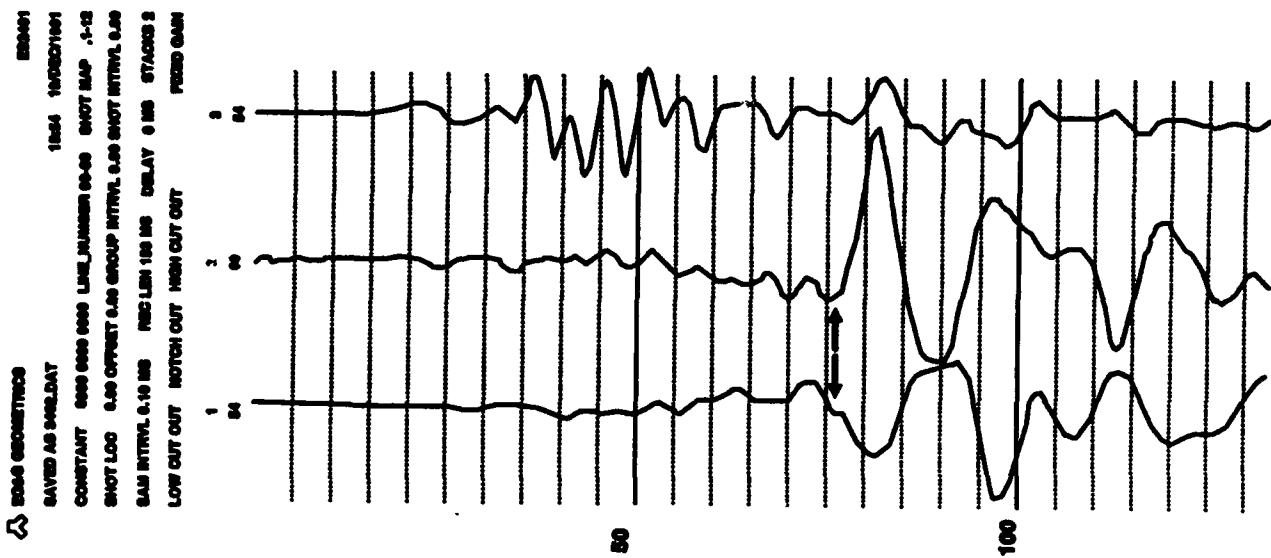
Figure 11. Example of downhole S-wave trace reversals obtained by striking opposite ends of board

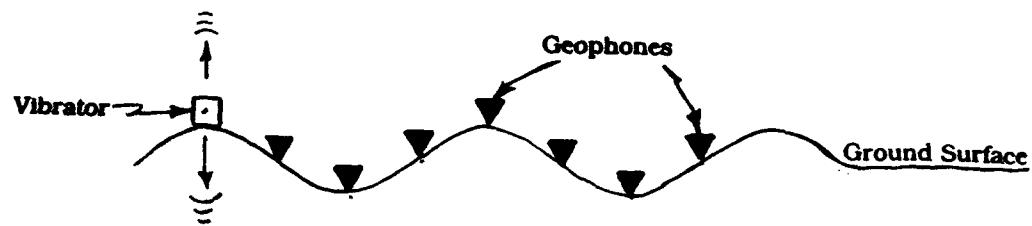
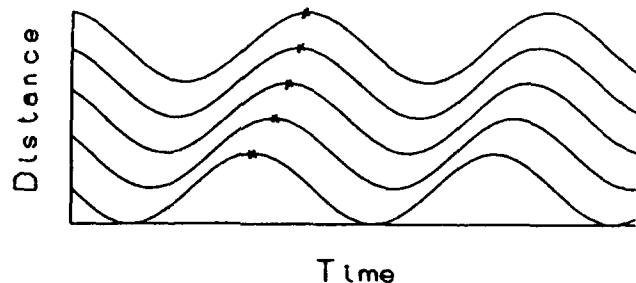
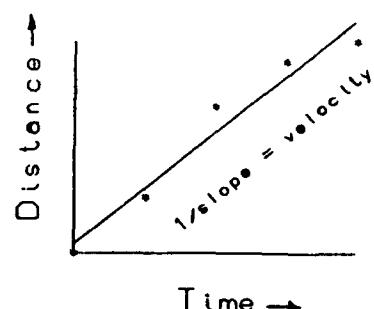
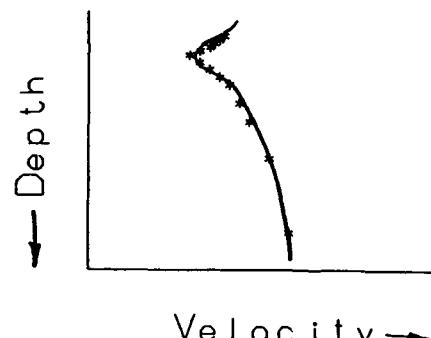
**Figure 13. Surface vibratory data reduction procedure**

The time of arrival (referenced to the zero geophone) of a particular event at each geophone in the array was measured and plotted versus the respective distances of the geophones from the reference geophone. The R-wave velocity for each frequency was determined from the slope of the best-fit line obtained for the plot. Knowing the frequency and the R-wave velocity, a corresponding wave length was computed by dividing the velocity by the frequency. Wave velocities thus derived are assumed to be average values for an effective depth of one-half the wavelength. The R-wave data collection and reduction techniques are illustrated in Figure 13.
