Technical Report GL-94-1  
January 1994

# In Situ Geophysical Investigation of the Pile Test Section, Sardis Dam, Mississippi

by José L. Llopis  
Geotechnical Laboratory

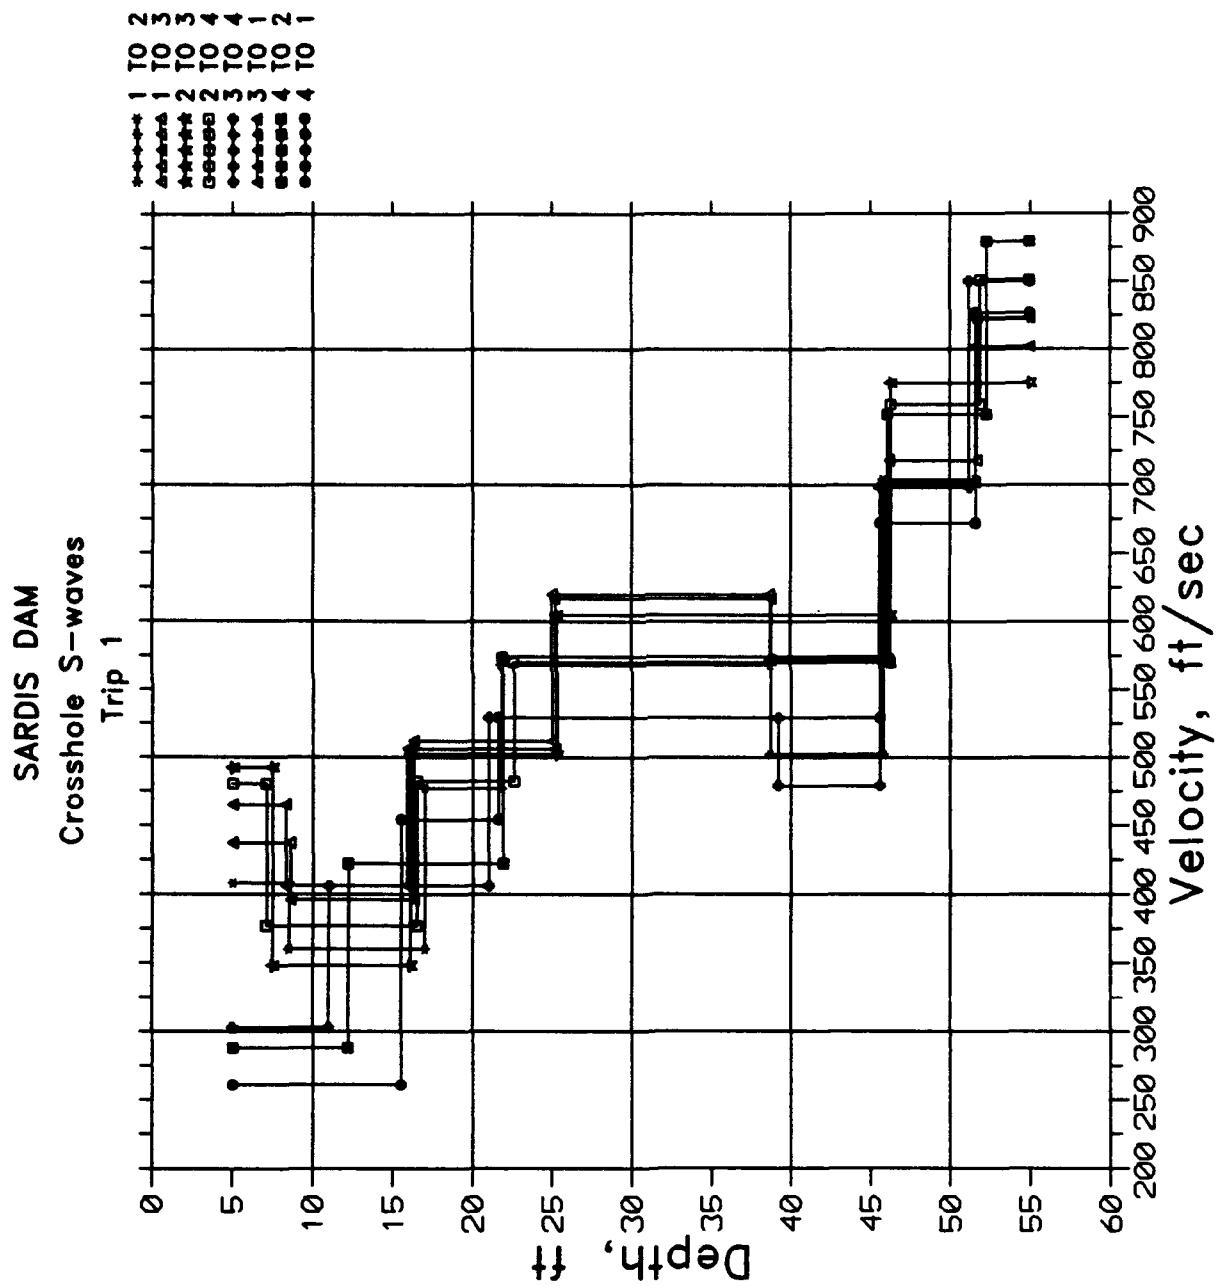
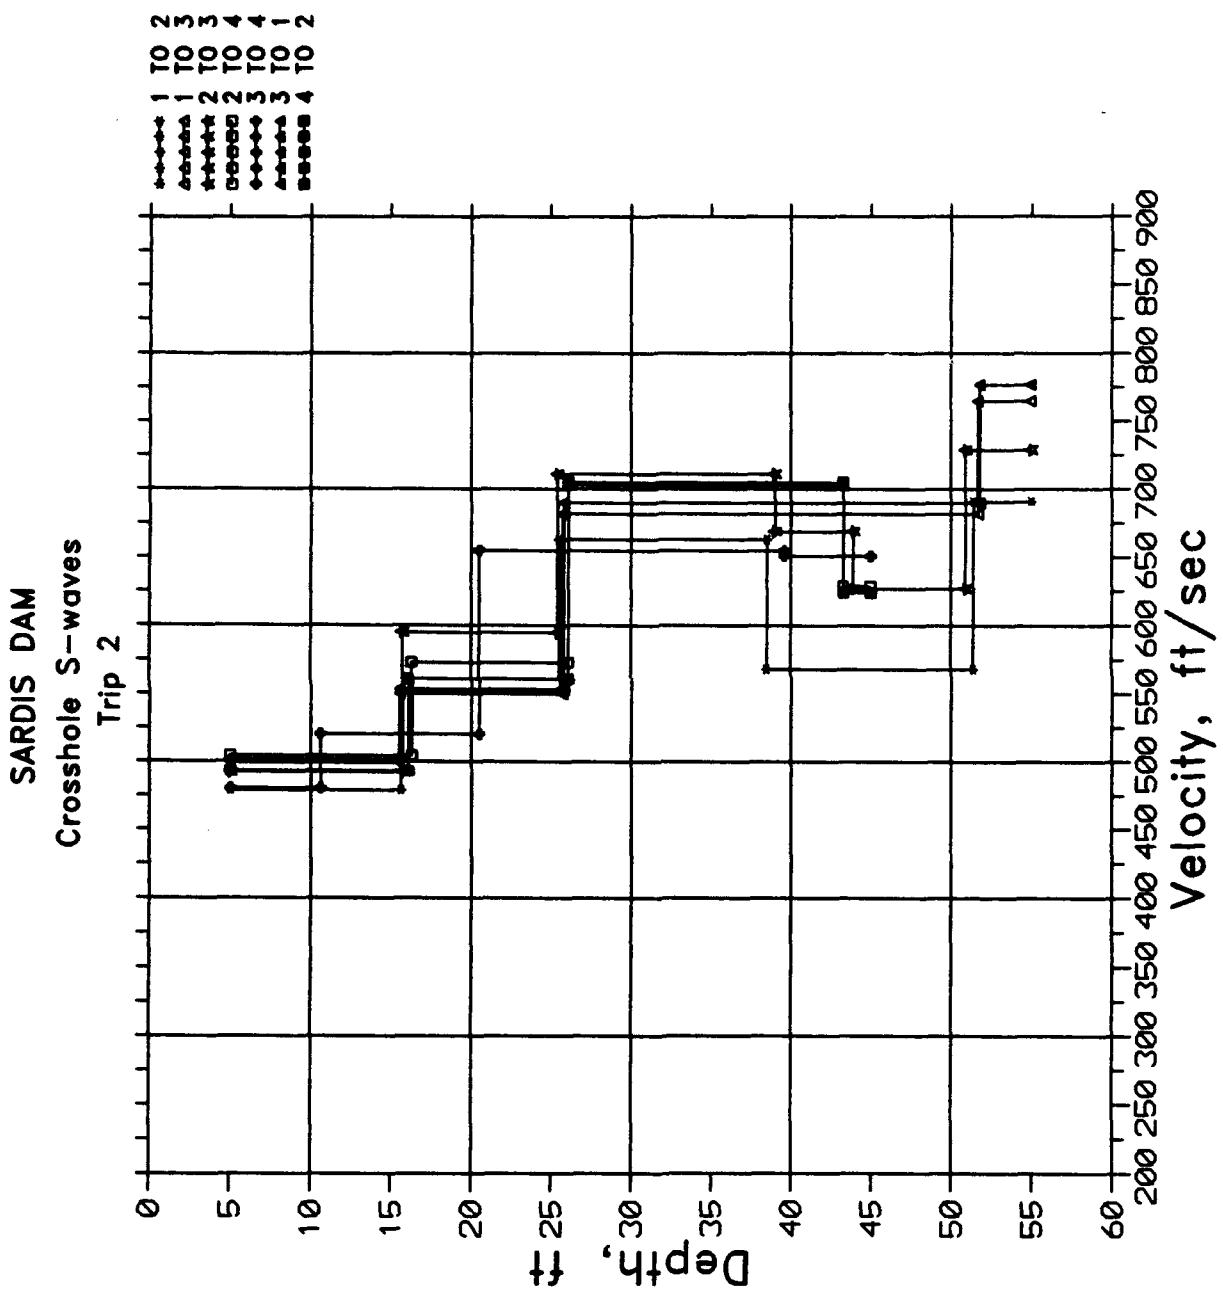
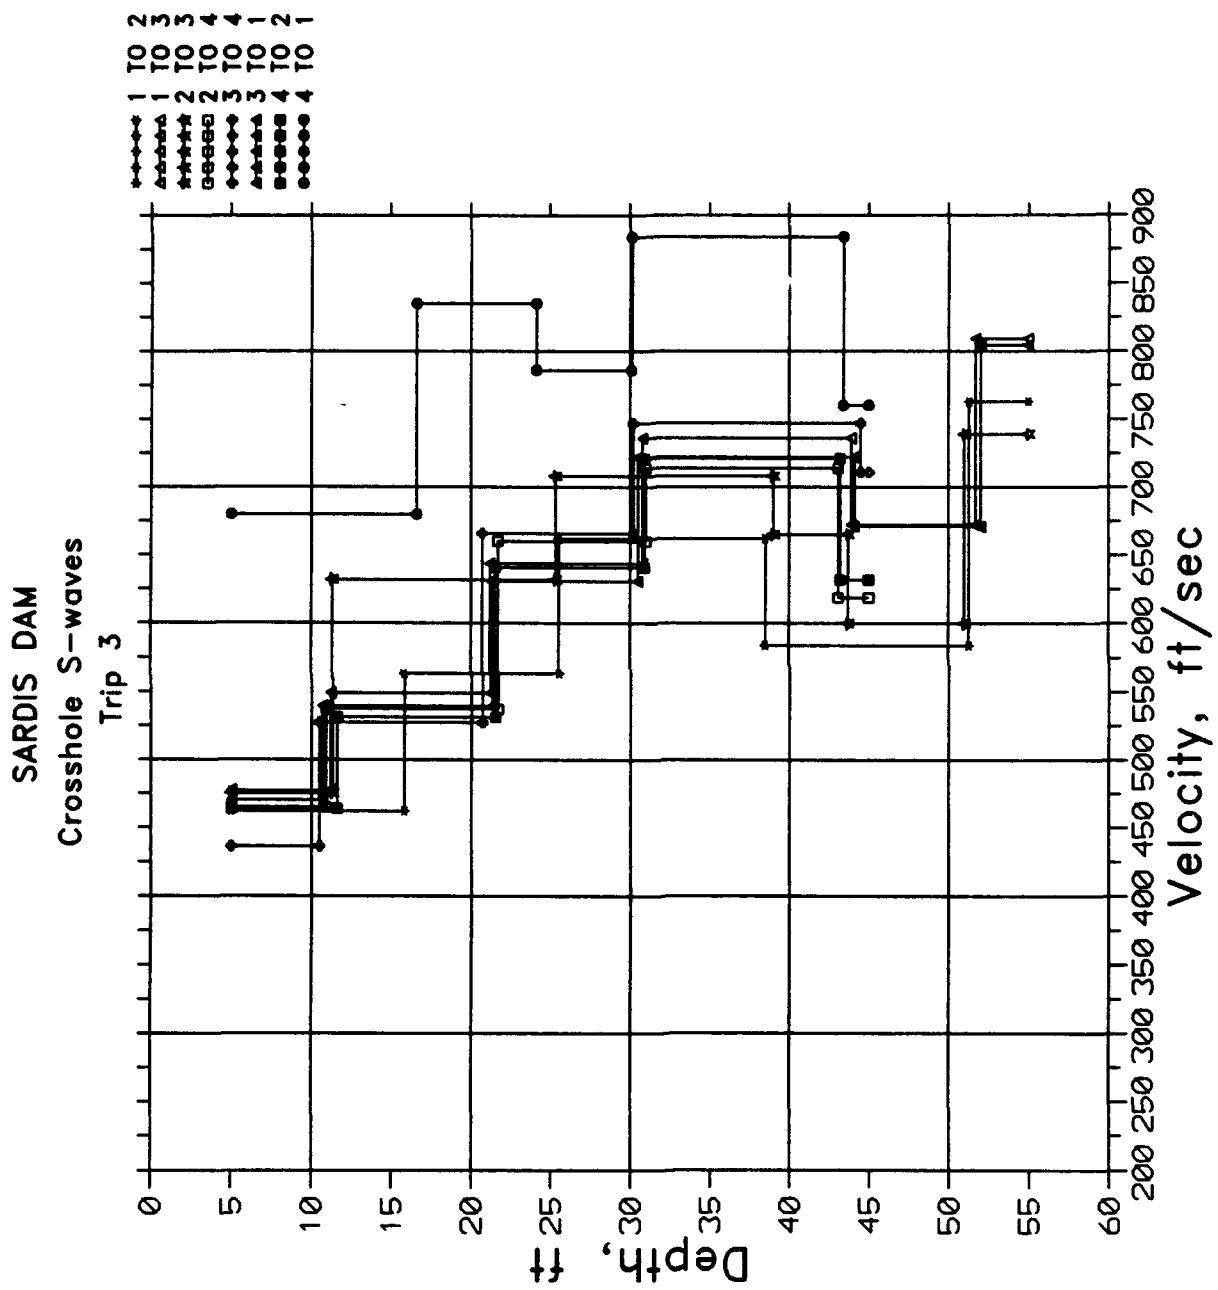
Figure 14. Crosshole S-wave velocity versus depth, Trip 1

Figure 15. Crosshole S-wave velocity versus depth, Trip 2

Figure 16. Crosshole S-wave velocity versus depth, Trip 3

The CROSSHOLE program results for the crosshole tests conducted during trips 1, 2 and 3 are presented as plots of velocity versus depth as shown in Figures 14 through 16, respectively. The velocities obtained for each boring set during trip 1 (Figure 14) agree very well with the exception of the upper 15 ft. The velocity discrepancy between boring sets in the upper 15 ft is probably due to the inability to accurately pick the time of arrival of the S-wave because of signal attenuation through the loose soil (fill) in this depth interval. Velocity agreement between boring sets for trips 2 and 3 (Figures 15 and 16) are also very good. It is noted that the velocities measured between borings 4 and 1, indicated in Figures 15 and 16 by the filled circles, are significantly higher than the velocities for the other borehole sets. The pile, located between borings 1 and 4 (Figure 17), has a marked effect on the surrounding soil as illustrated by the high S-wave velocity between these two borings. The increased S-wave velocity between these borings was presumably chiefly caused by the densified soil surrounding the pile rather than the pile itself. Based on an S-wave velocity for concrete of 8000 fps (Rix 1988) the time for an S-wave to travel through a 24-in concrete pile would be approximately 0.25 msec, a very small fraction of the average travel time of 13.5 msec.

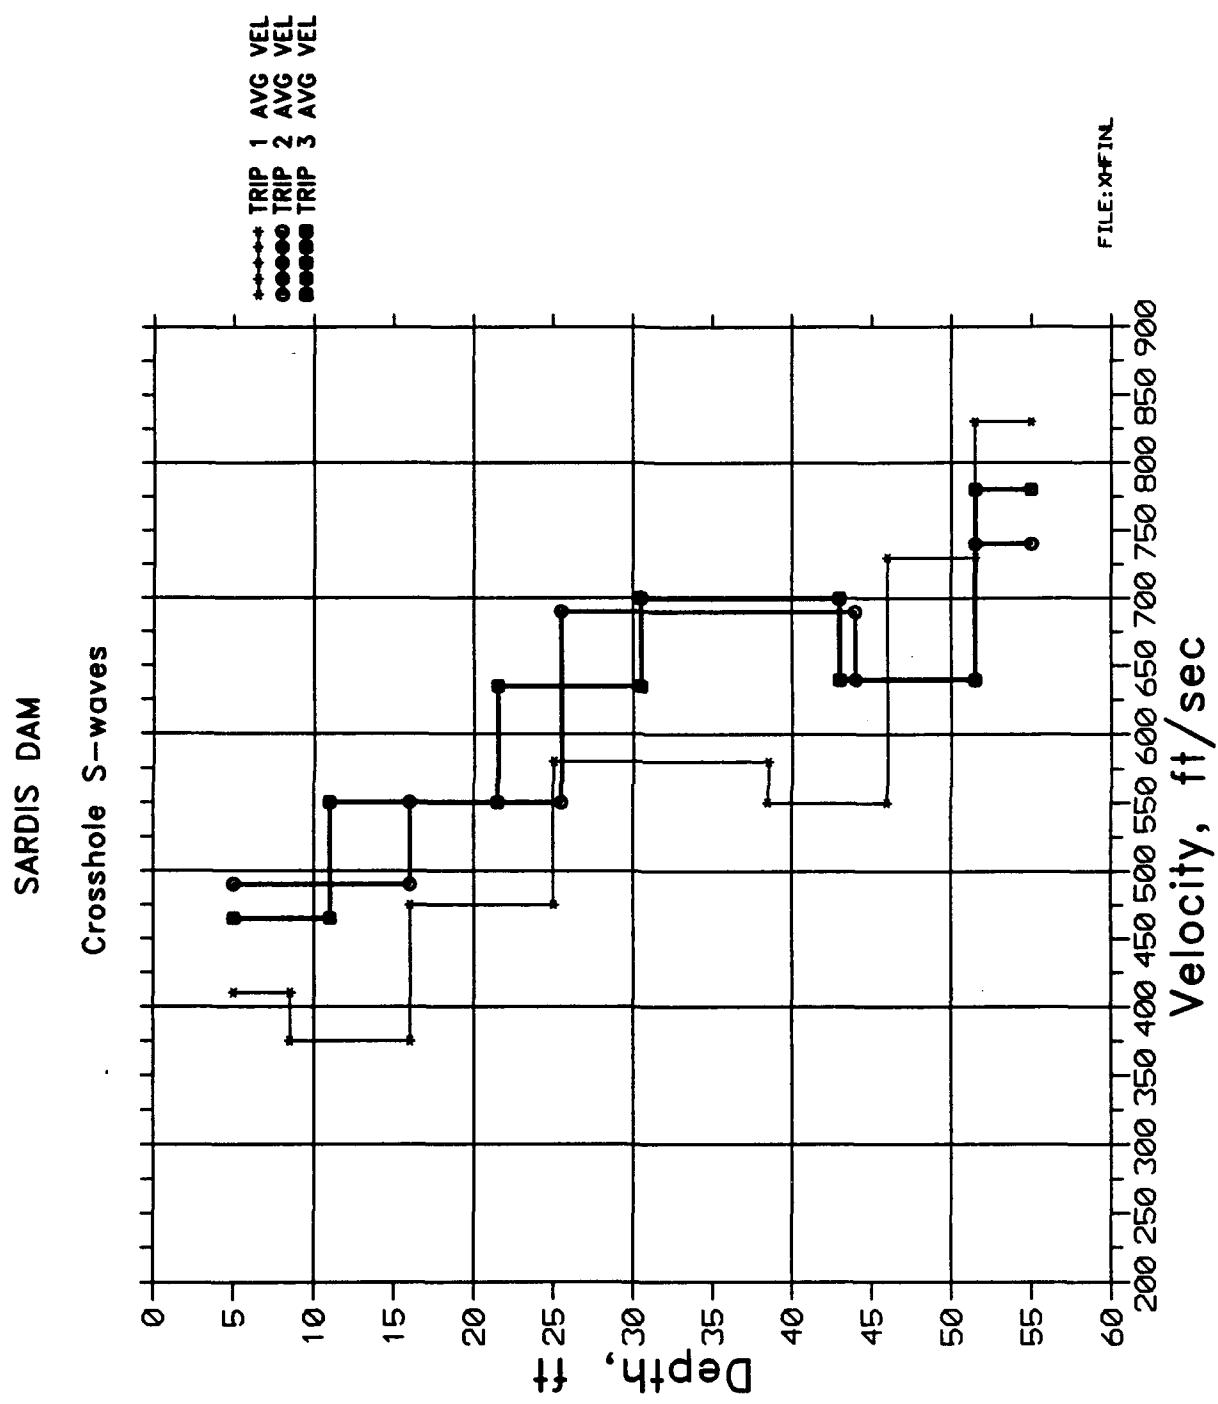
Figure 18. Average crosshole S-wave velocities for Trips 1, 2, and 3

Average velocity profiles were determined for the three trips and are shown in Figure 18. The Figure 18 shows that the post-treatment velocities are considerably higher than the pre-treatment velocities. It is noted that the velocities obtained from crosshole tests conducted between borings 4 and 1 were not used to determine the average velocity profiles for trips 2 and 3 (post-treatment).

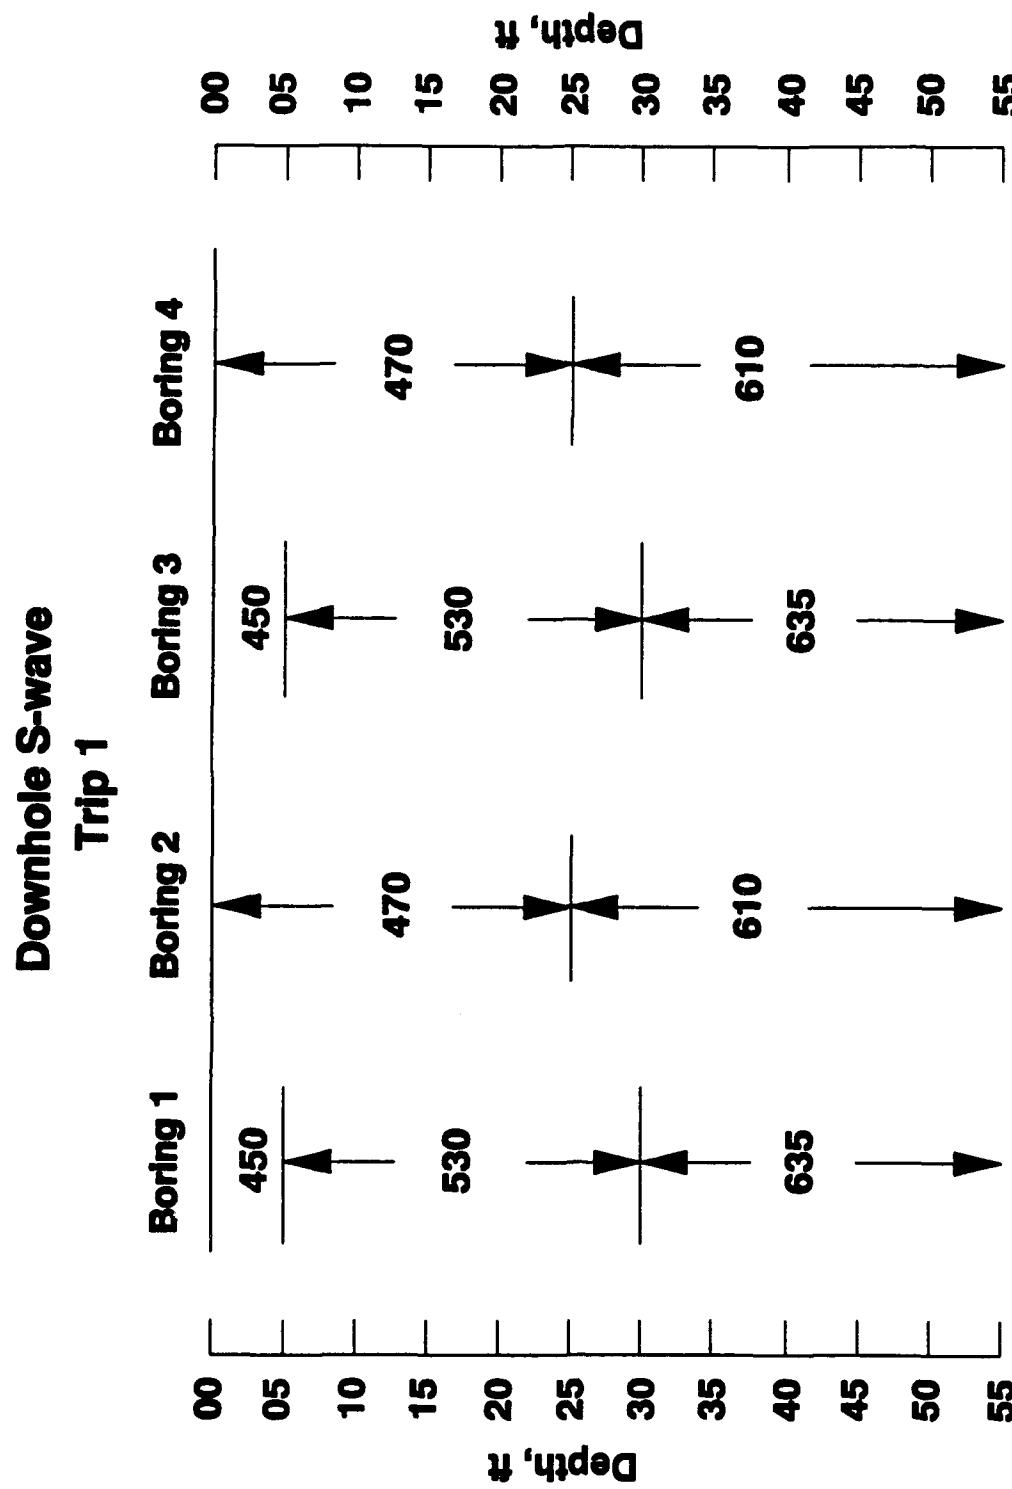
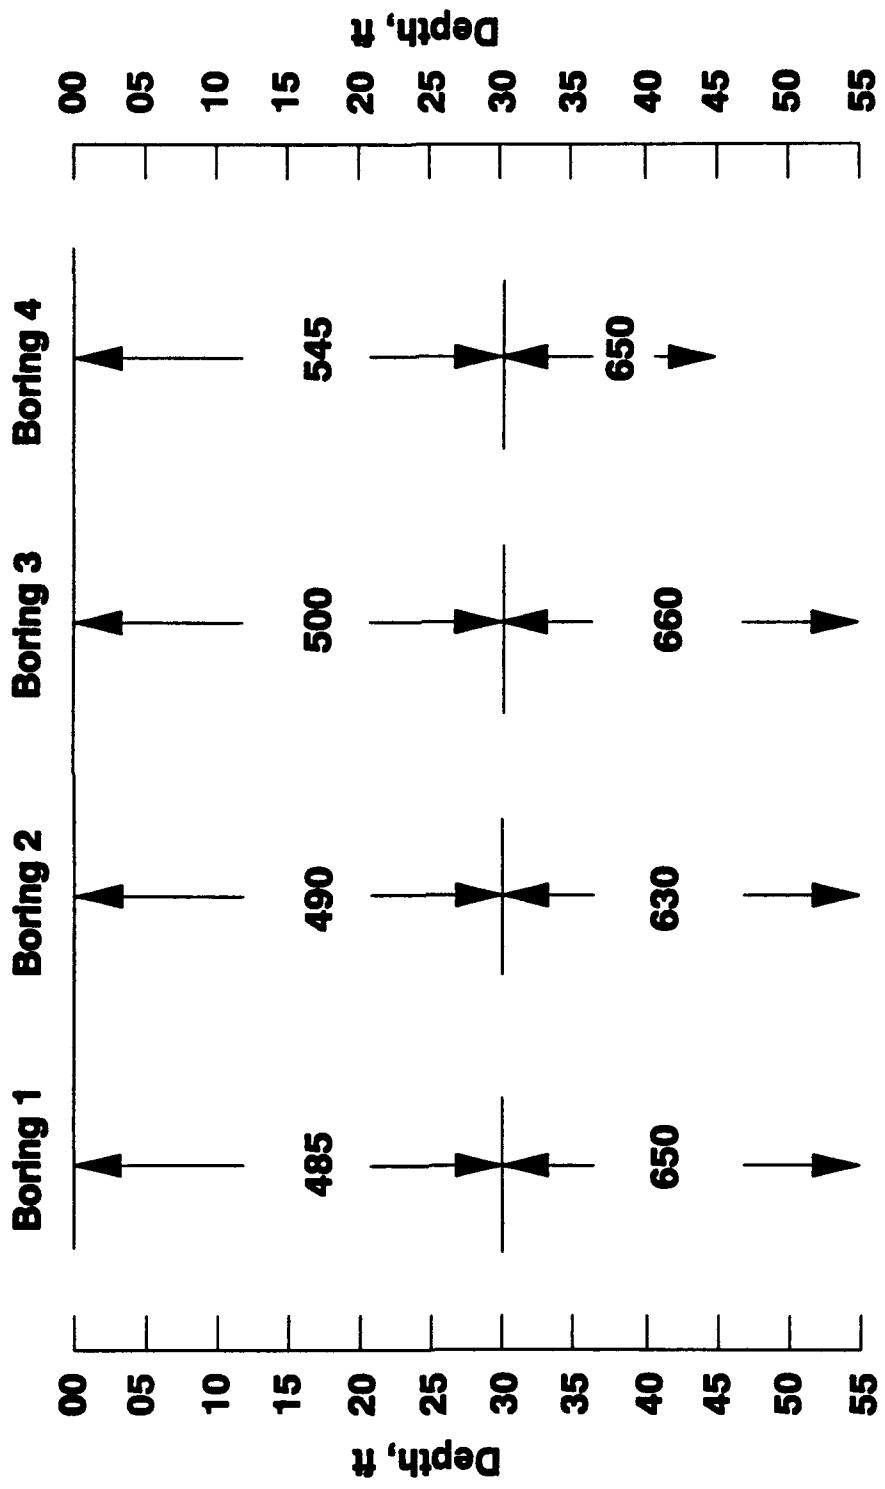
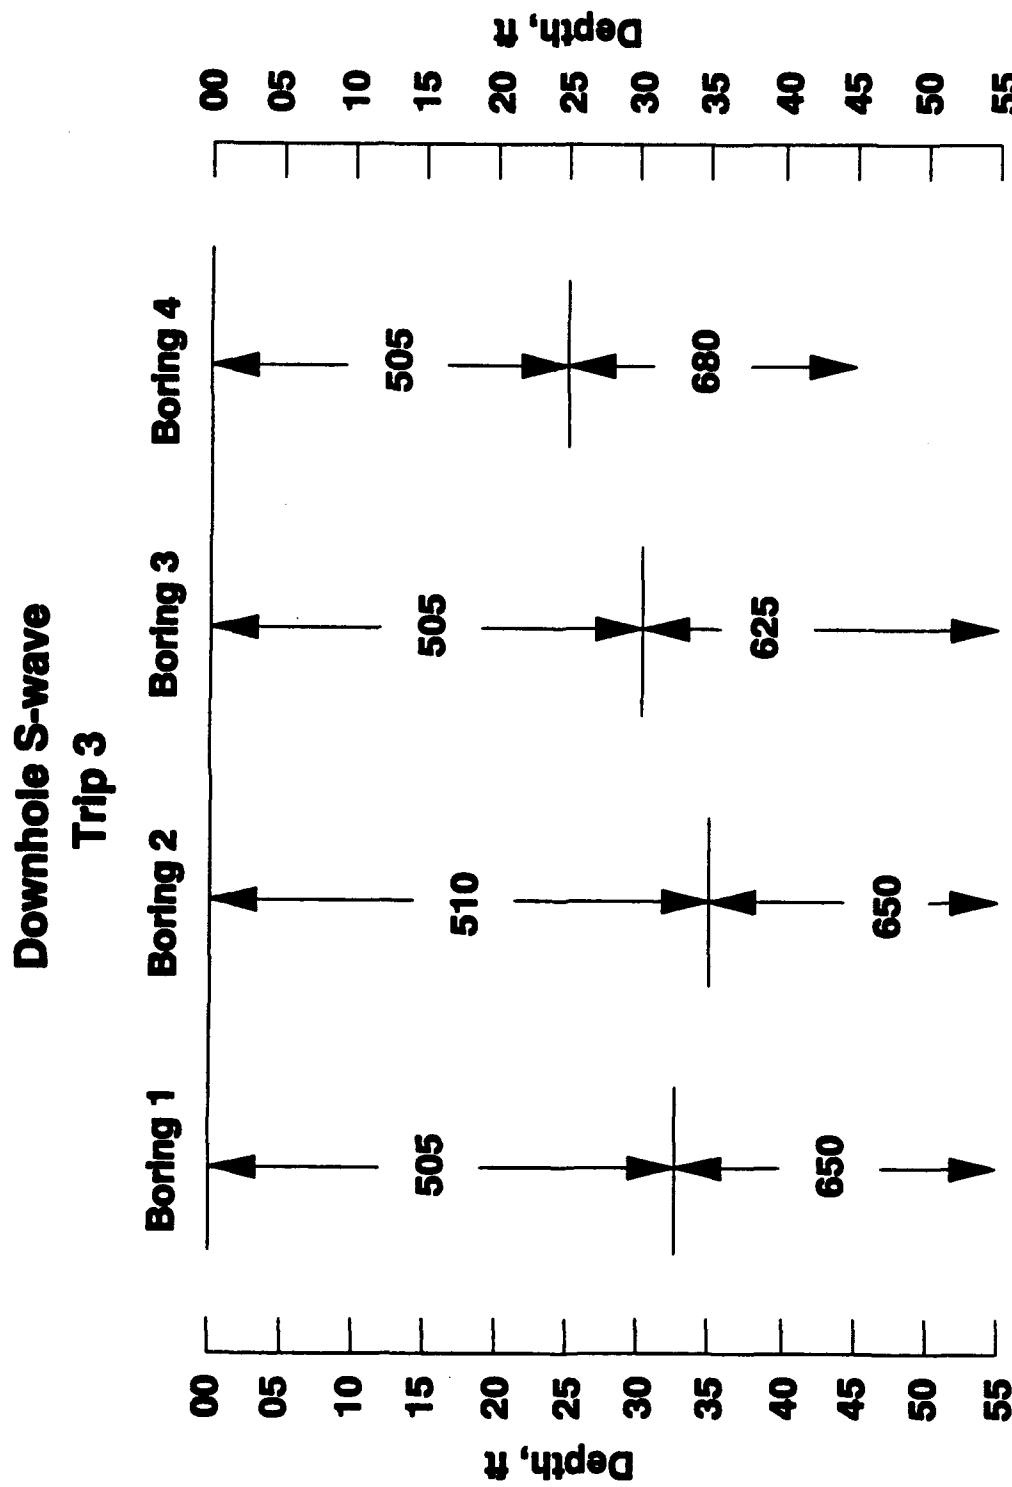
Figure 31. Downhole S-wave composite, Trip 1

Figure 32. Downhole S-wave composite, Trip 2

Figure 33. Downhole S-wave composite, Trip 3

The results of the downhole tests obtained during the three site visits are presented in Figures 19 through 30. The plots are presented as time versus slant distance. The slant distance is the distance from the source to the receiver and for depths greater than 20 ft, depth and slant distance are approximately equal. A summary of the downhole test results for trips 1, 2, and 3 are presented in Figures 31 through 33, respectively. Figures 31 through 33

show that for a given trip the downhole S-wave velocities agree very well between borings. Figure 34 presents the average downhole velocities for each of the three trips. The results indicate basically two velocity layers with the layer interface occurring at an approximate depth of 30 ft. Referring to Figure 34 it can be seen that the average velocities for trip 1 are lower than those for trips 2 and 3 however, they are not considered significantly lower. Thus, it can be concluded that no significant S-wave velocities differences were noted between pre- and post-treatments using the downhole testing method.

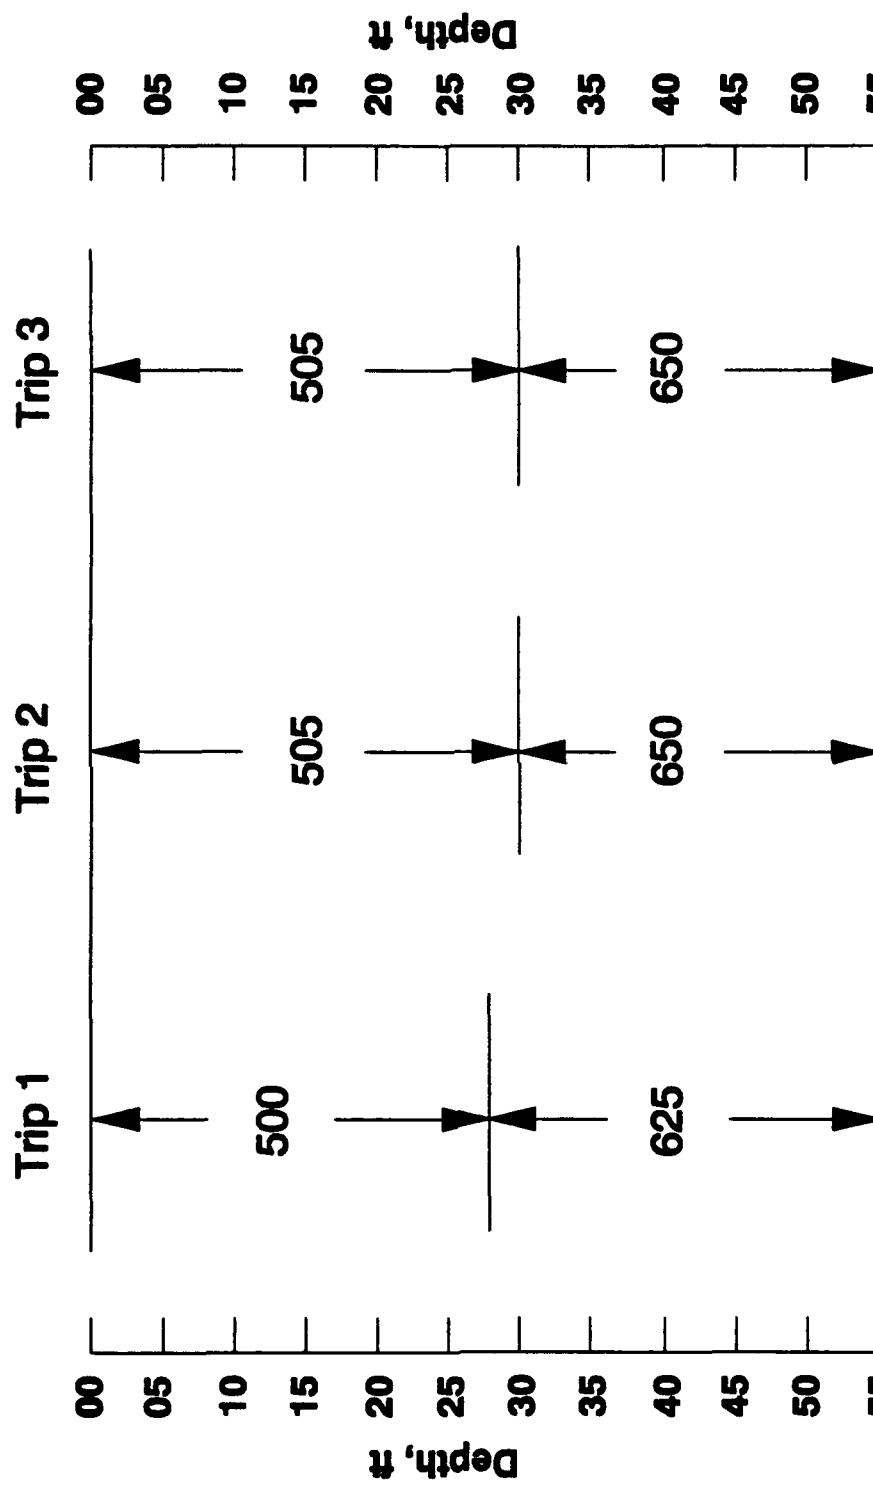
Figure 34. Average downhole S-wave velocities for Trips 1, 2, and 3
