Technical Report GL-94-1  
January 1994

# In Situ Geophysical Investigation of the Pile Test Section, Sardis Dam, Mississippi

by José L. Llopis  
Geotechnical Laboratory

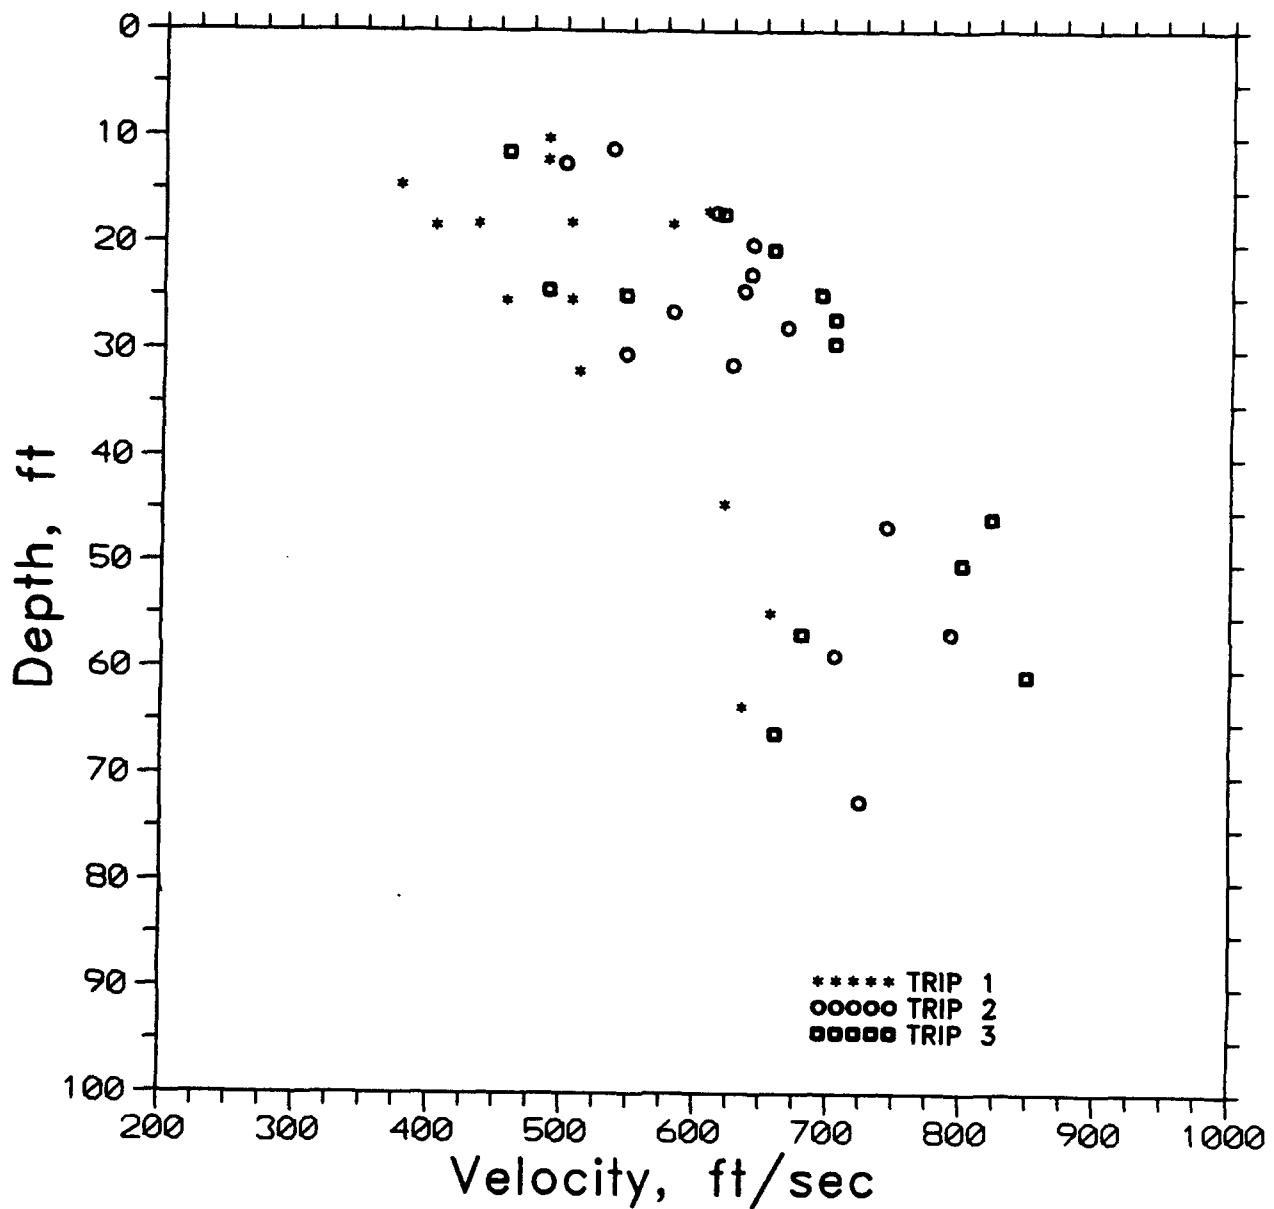
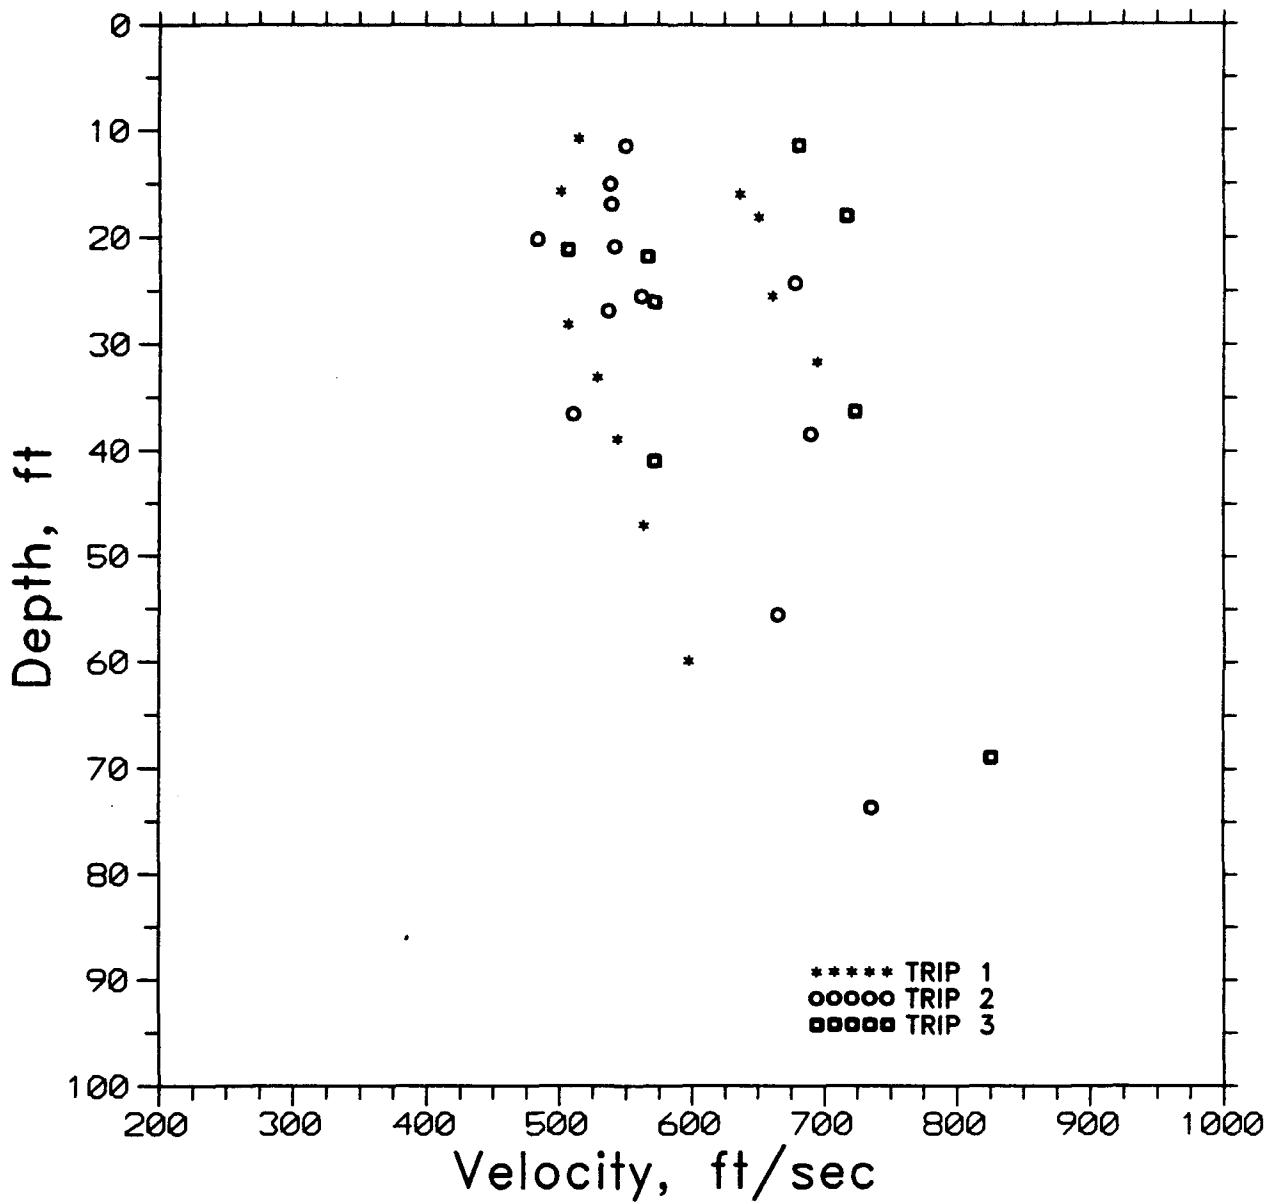
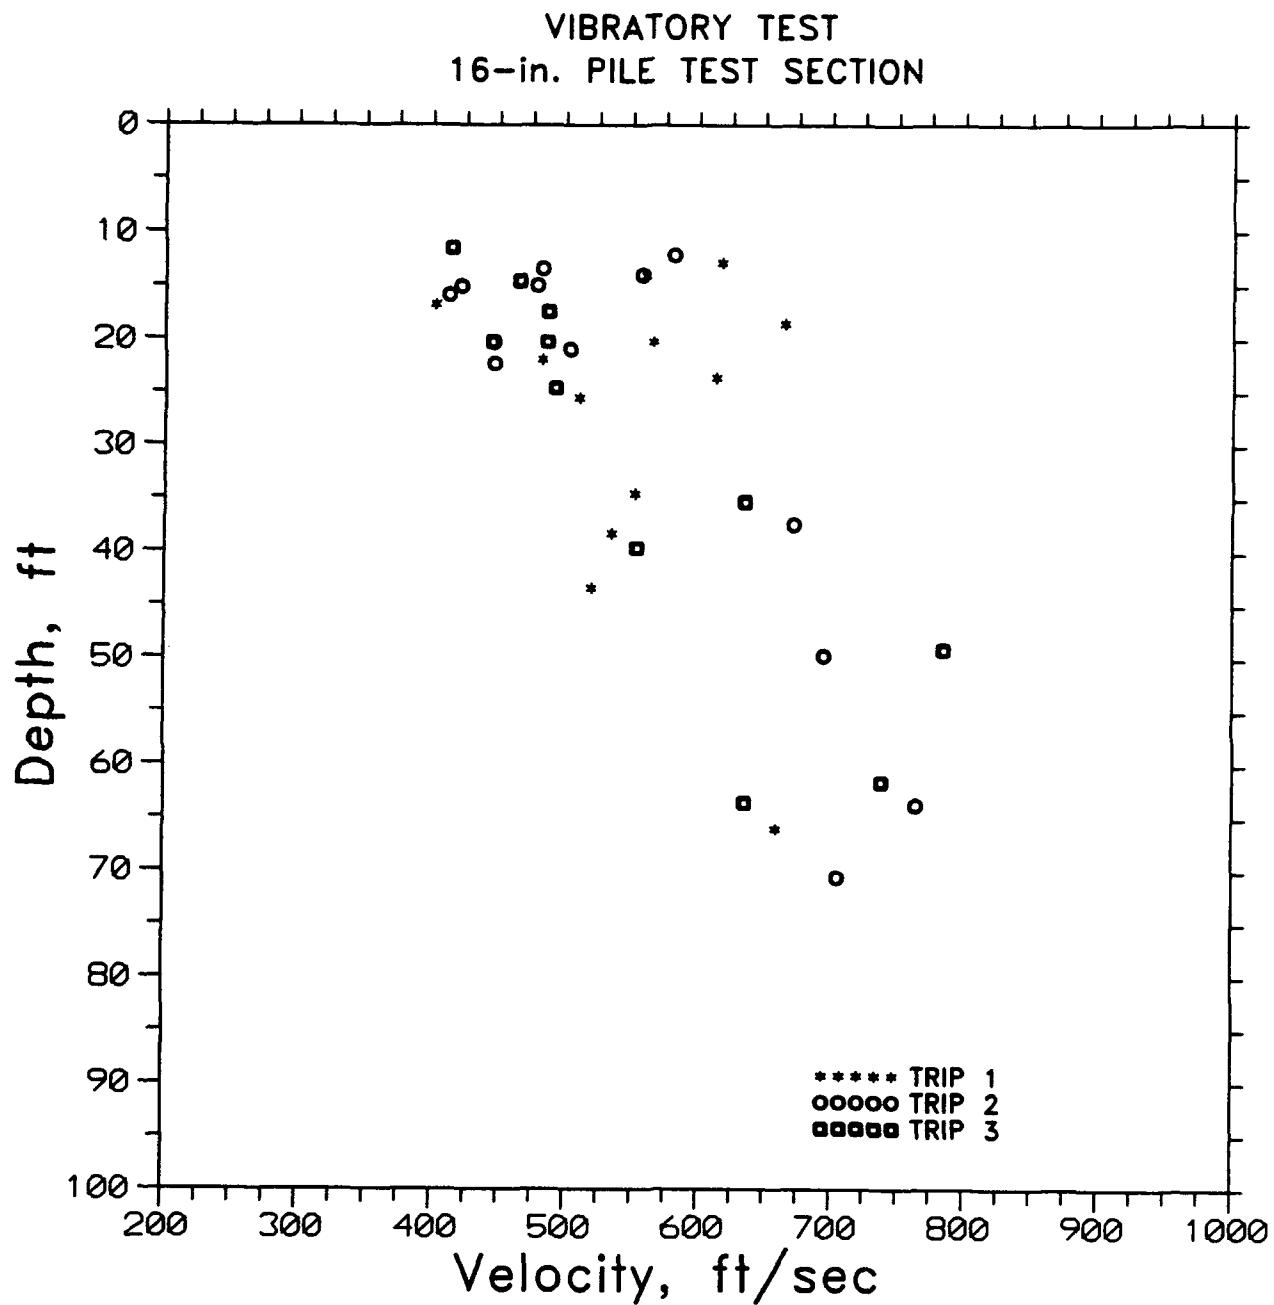
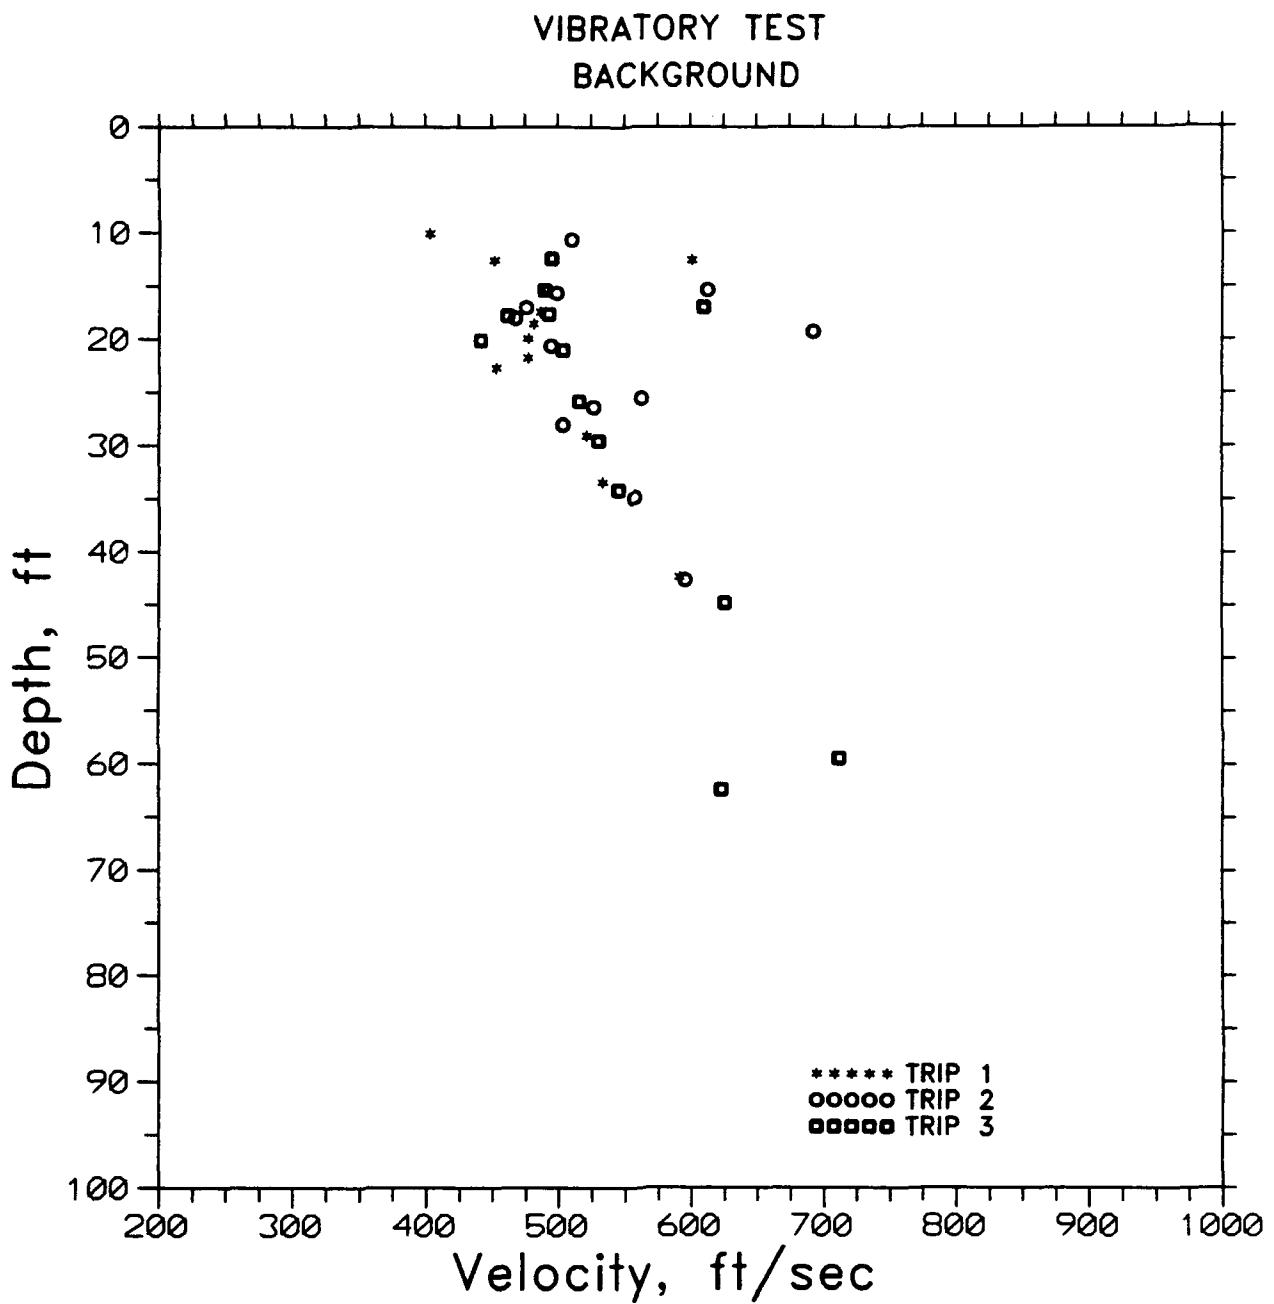
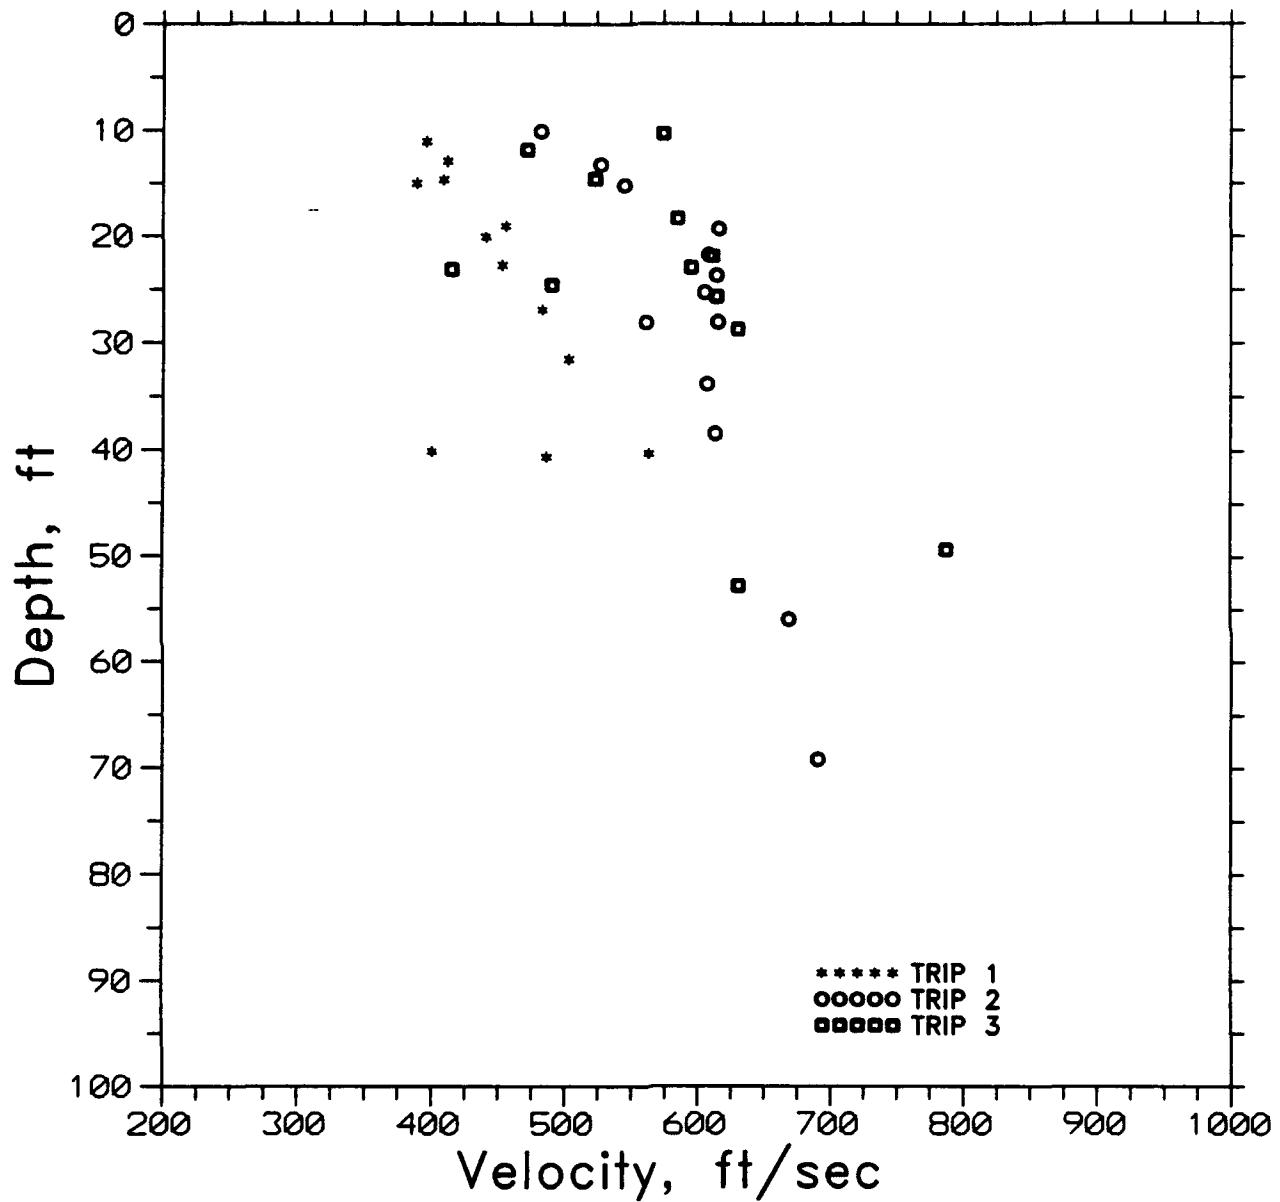
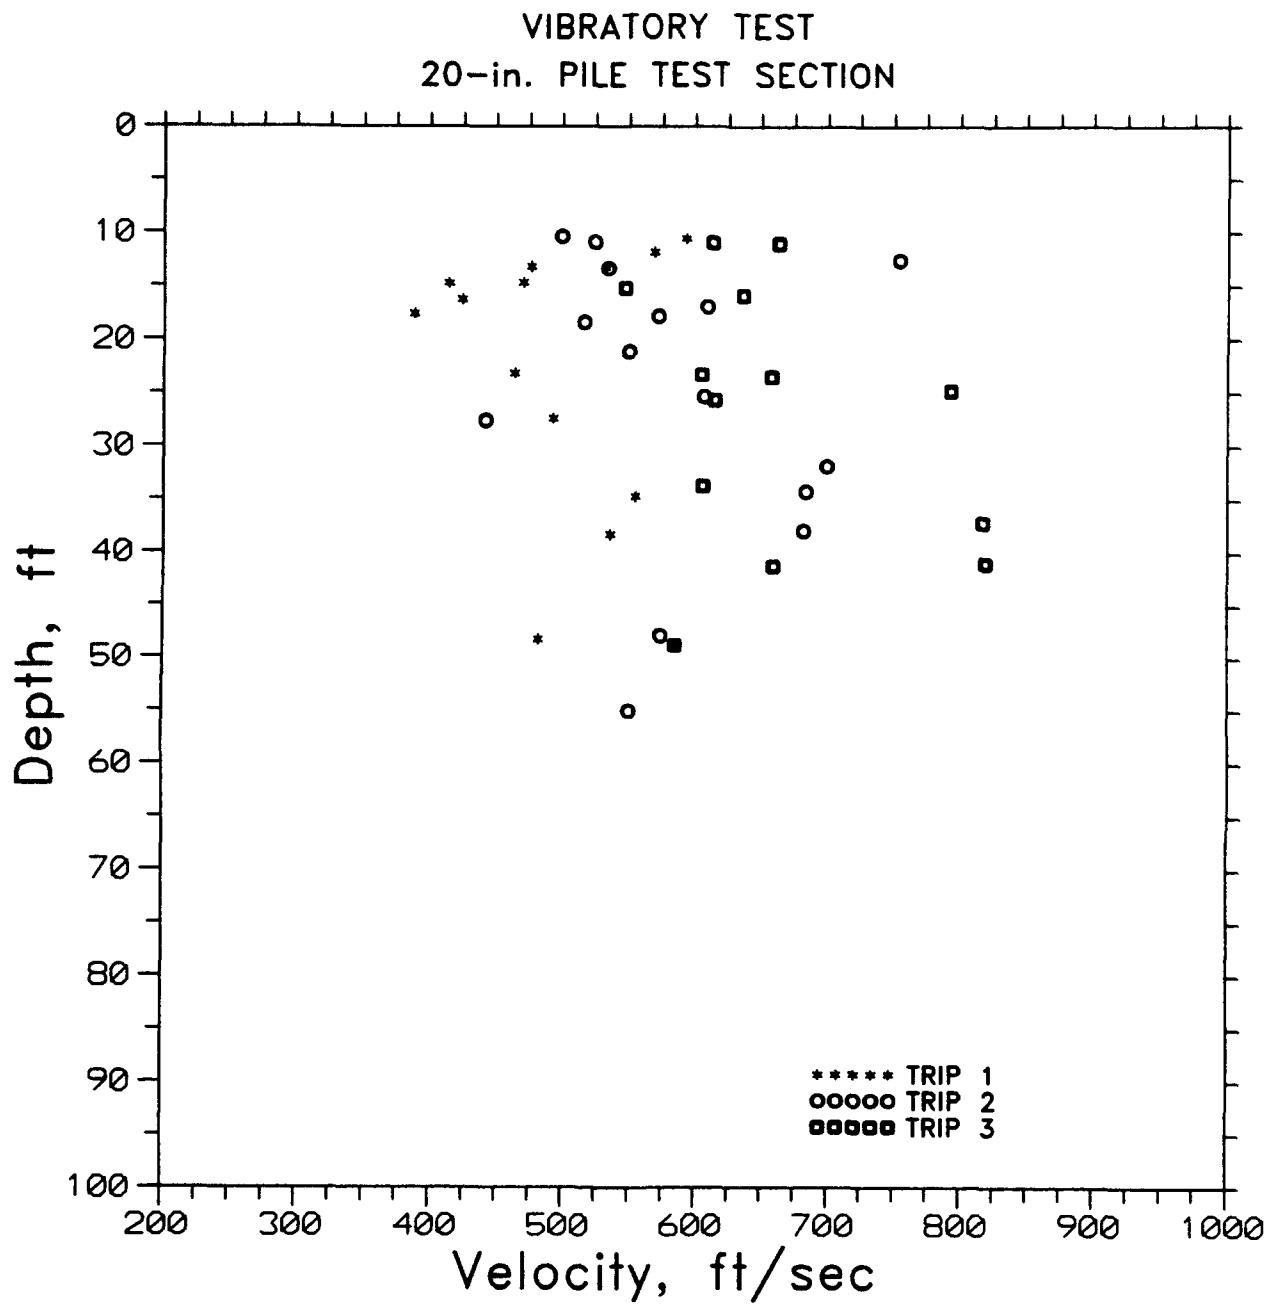
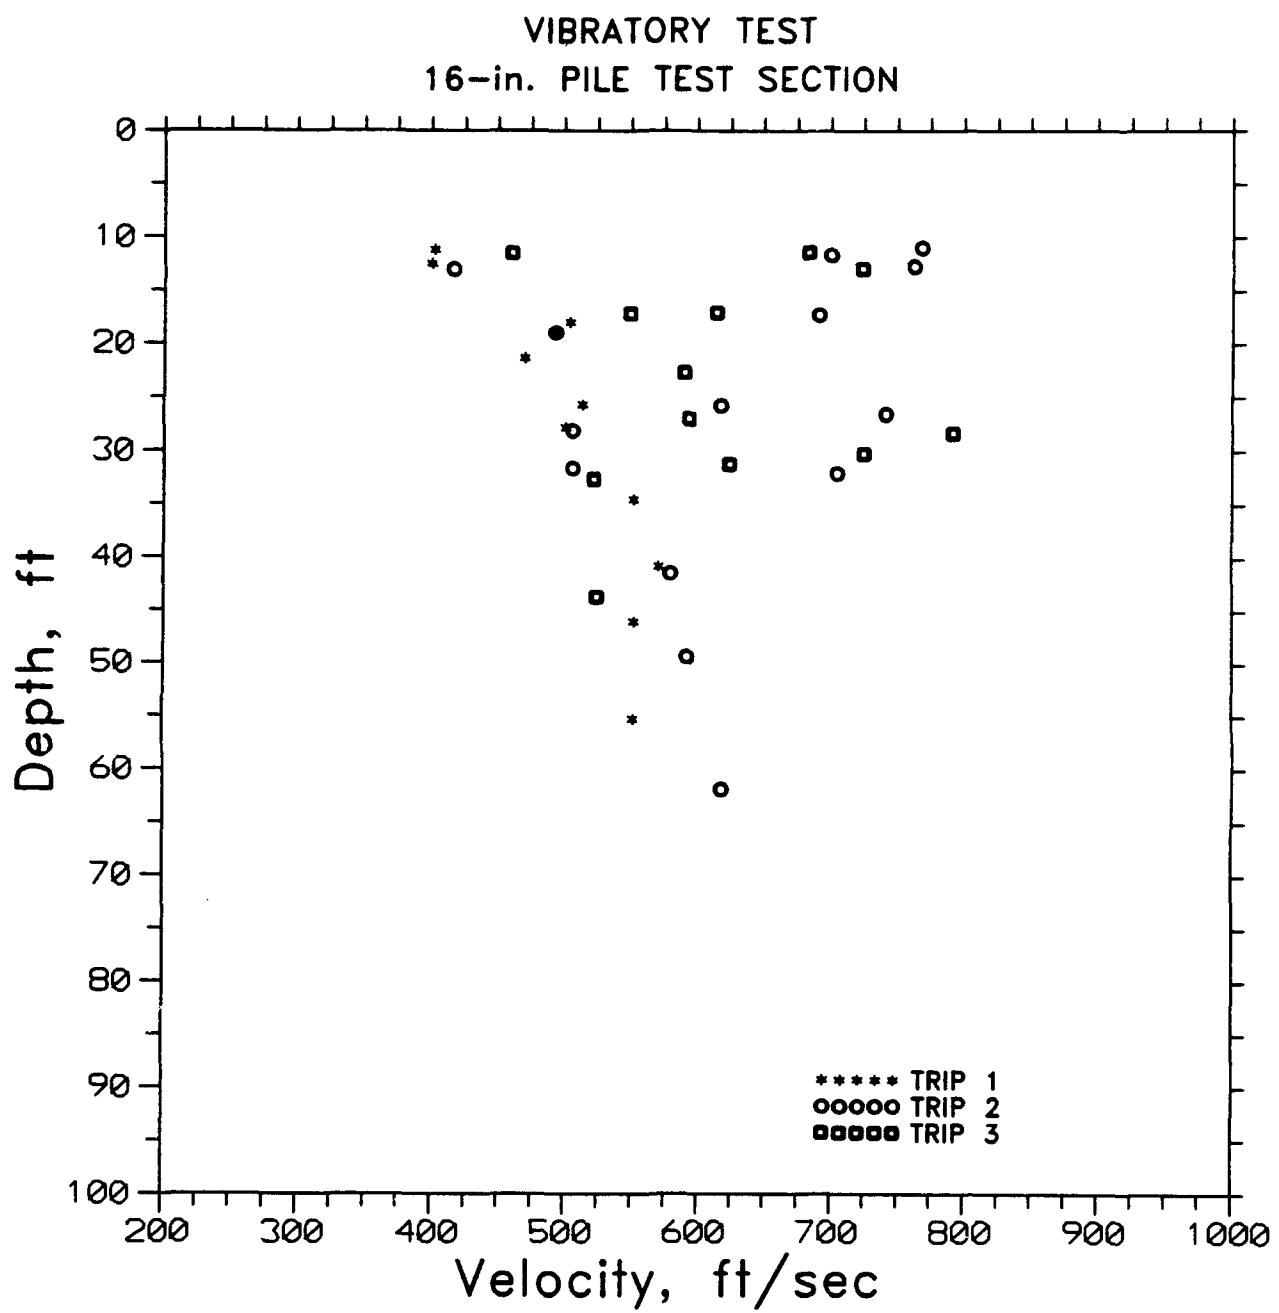
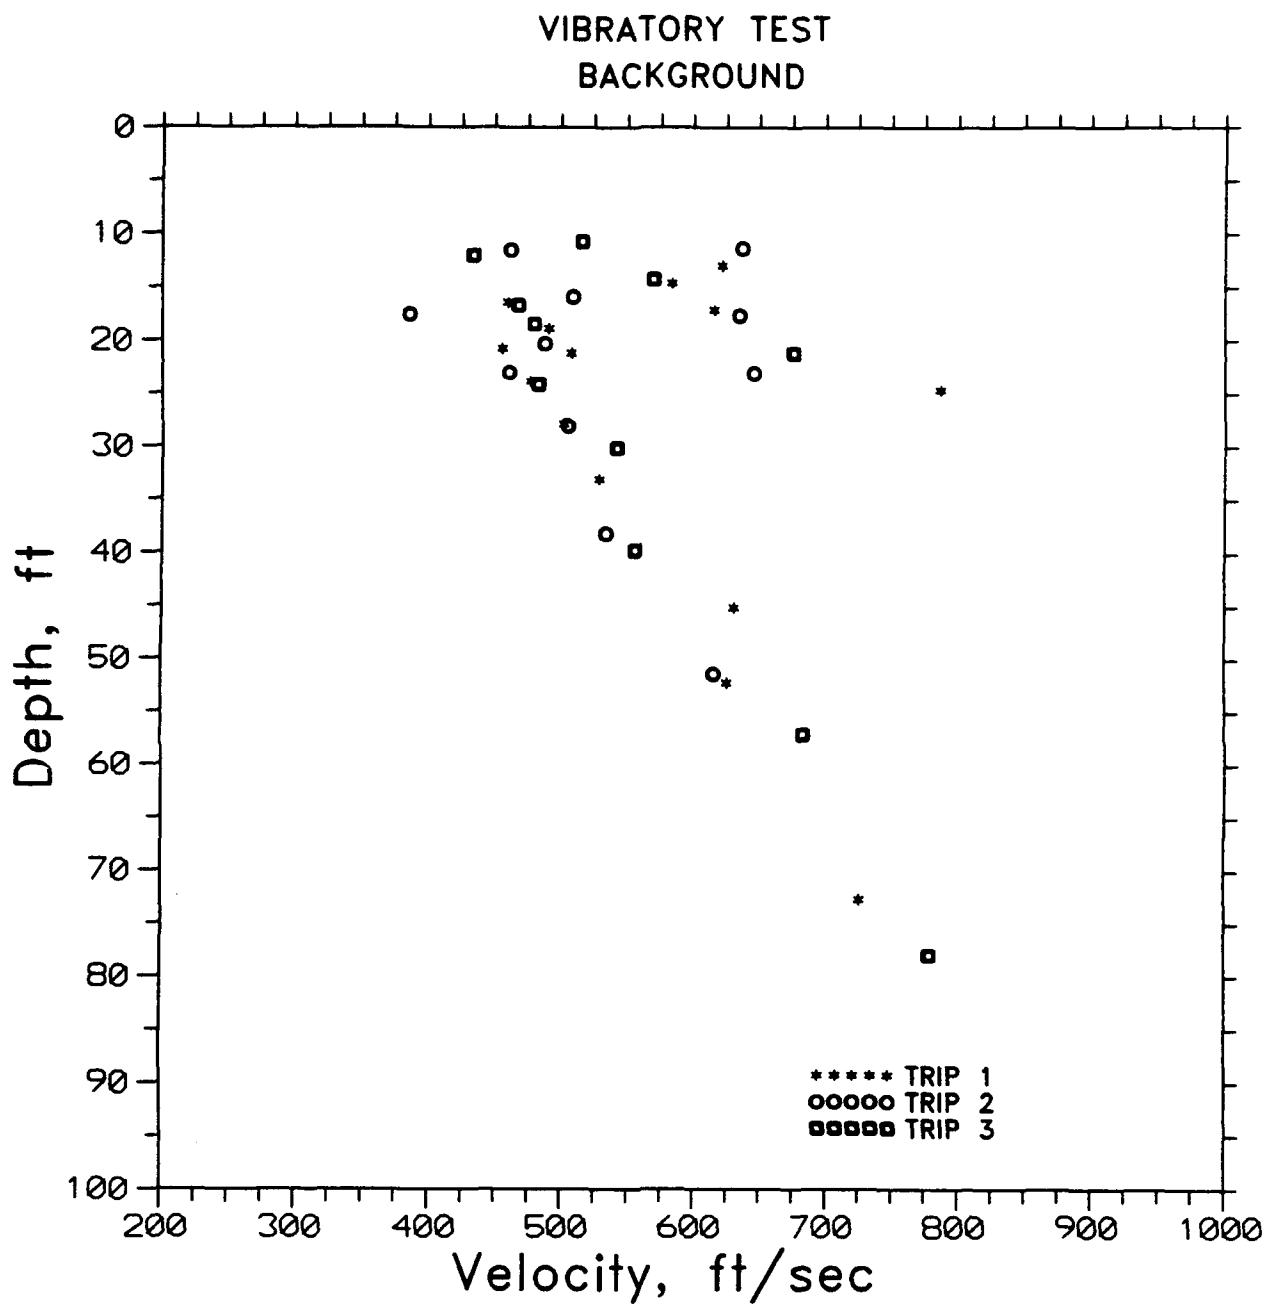
Figure 35. R-wave velocity versus depth, Line 1, 24-in pile test section, Trips 1, 2, and 3

Figure 36. R-wave velocity versus depth, Line 1, 20-in pile test section, Trips 1, 2, and 3

Figure 37. R-wave velocity versus depth, Line 1, 16-in pile test section, Trips 1, 2, and 3

Figure 38. R-wave velocity versus depth, Line 1, background area, Trips 1, 2, and 3

Figure 39. R-wave velocity versus depth, Line 2, 24-in pile test section, Trips 1, 2, and 3

Figure 40. R-wave velocity versus depth, Line 2, 20-in pile test section, Trips 1, 2, and 3

Figure 41. R-wave velocity versus depth, Line 2, 16-in pile test section, Trips 1, 2, and 3

Figure 42. R-wave velocity versus depth, Line 2, background area, Trips 1, 2, and 3

The vibratory tests were analyzed basically in two ways in an attempt to determine differences in soil velocity caused by the pile driving operations. The first method consisted of determining the R-wave velocity for each pile group as a function of time (for each trip). This was accomplished by analyzing the vibratory signal over a particular pile group to determine that group's phase velocities. Plots of velocity versus depth for the pile groups and background area were generated. The plots of velocity versus depth over each pile group as a function of time for Line 1 are presented in Figures 35 through 38 whereas, the plots for Line 2 are shown in Figures 39 through 42.

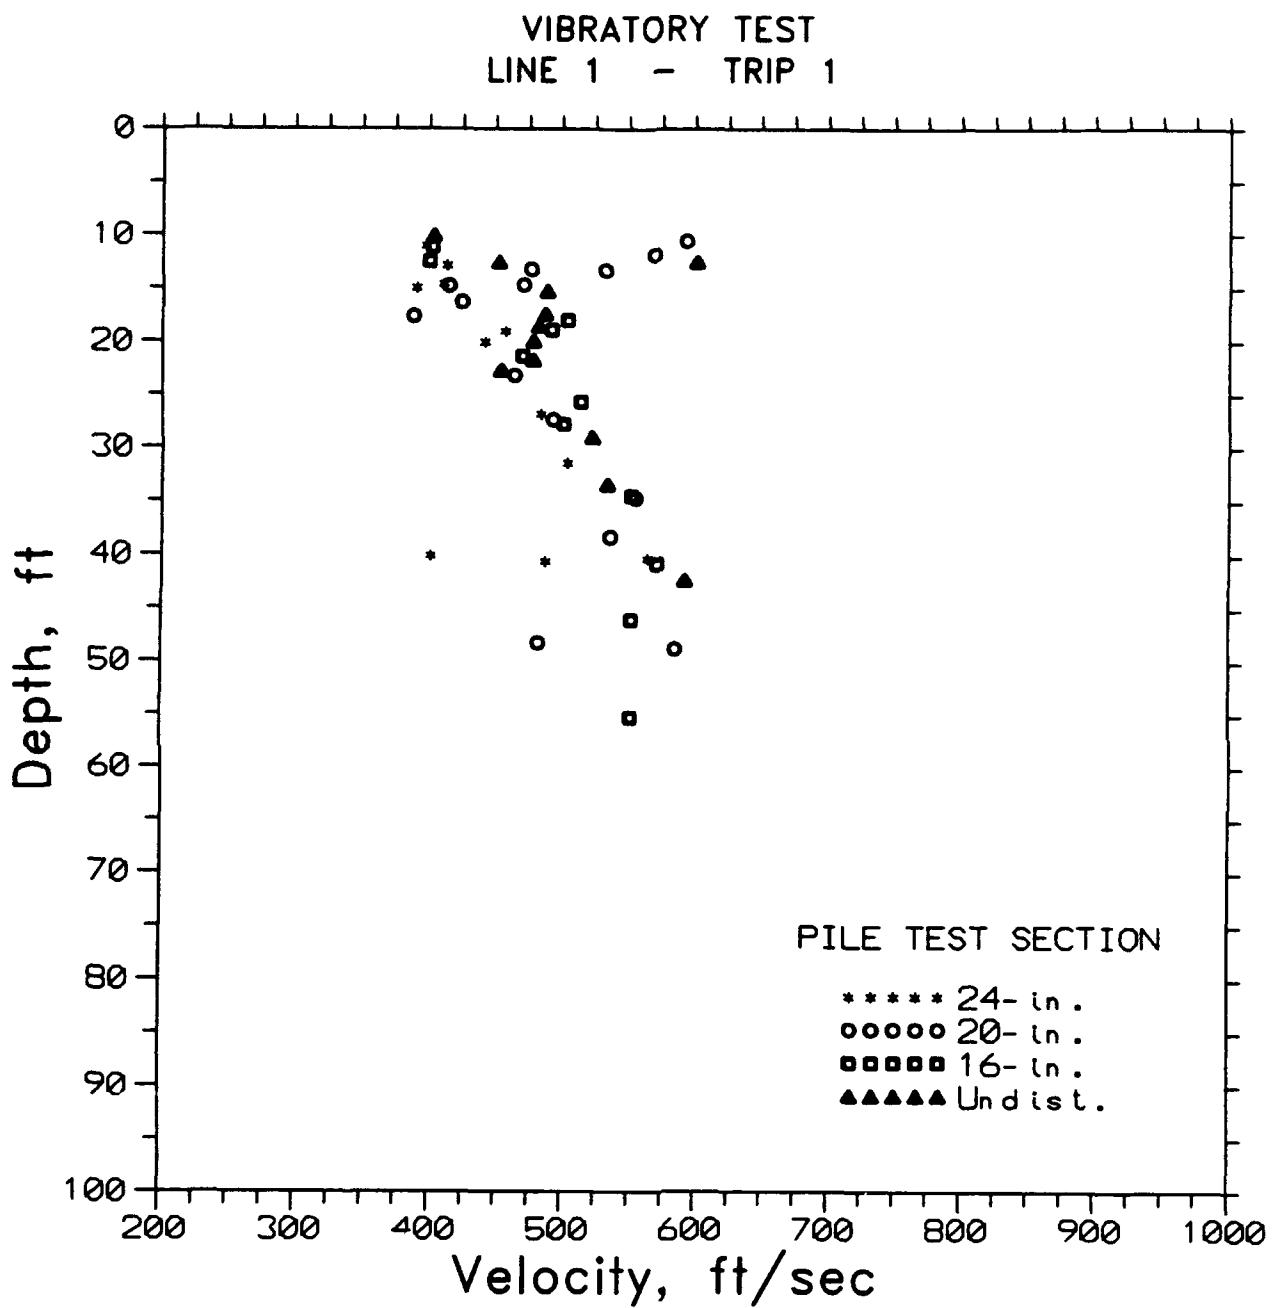
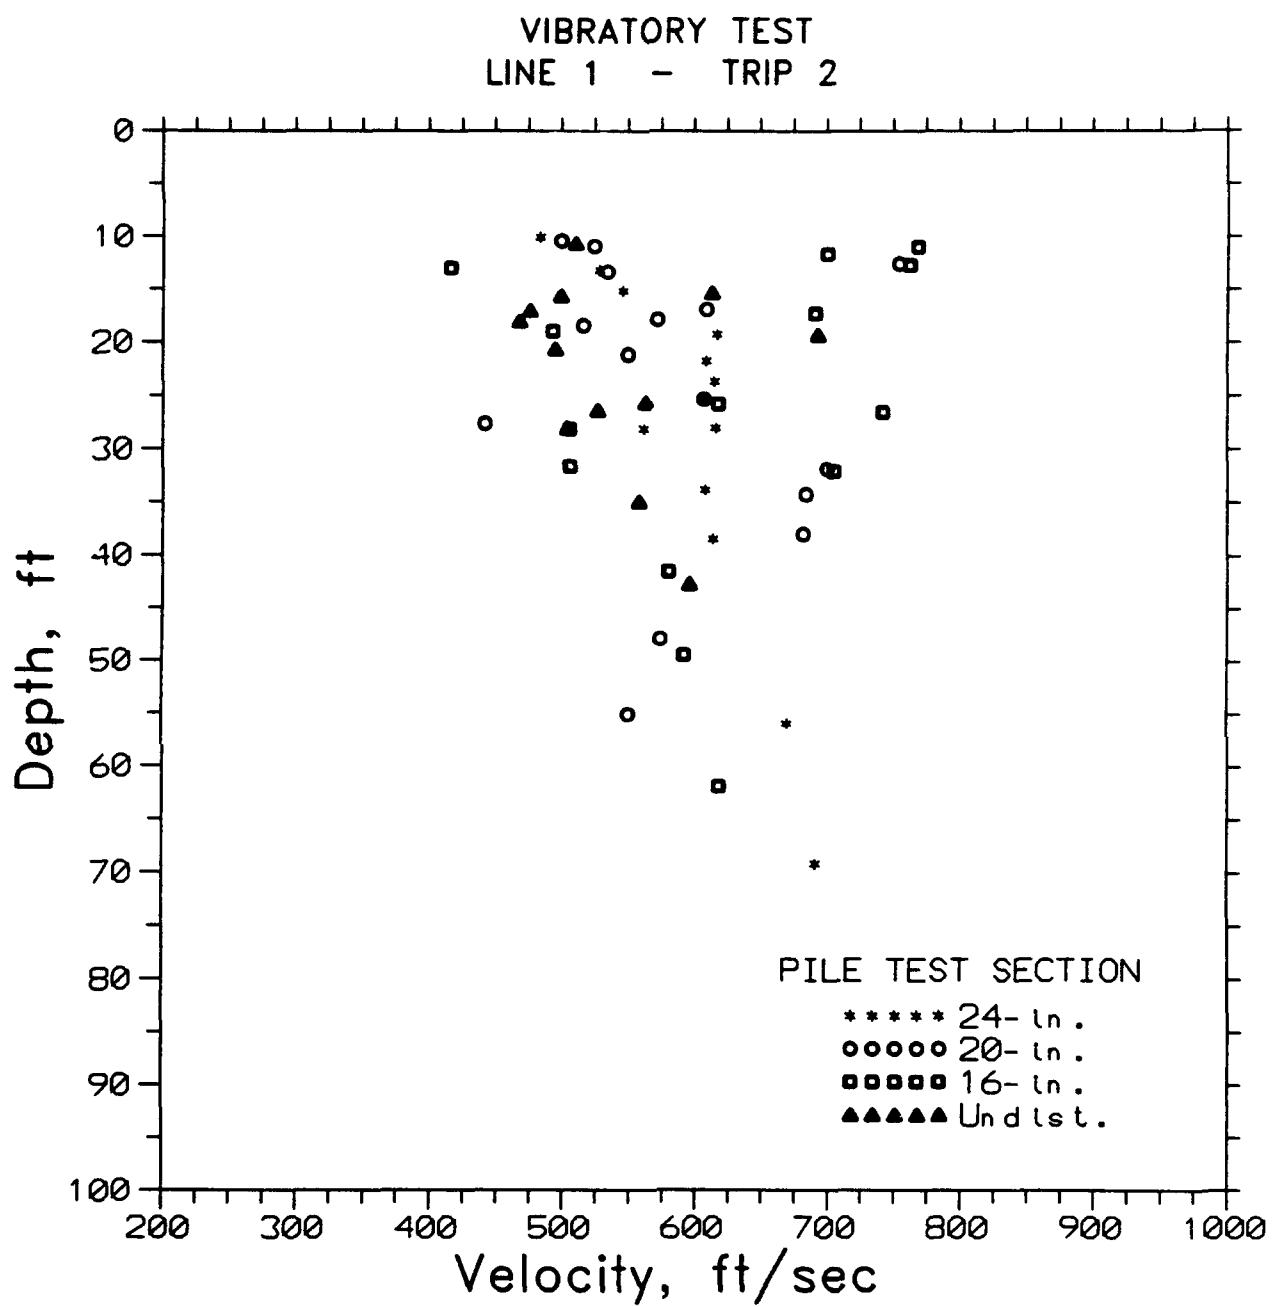
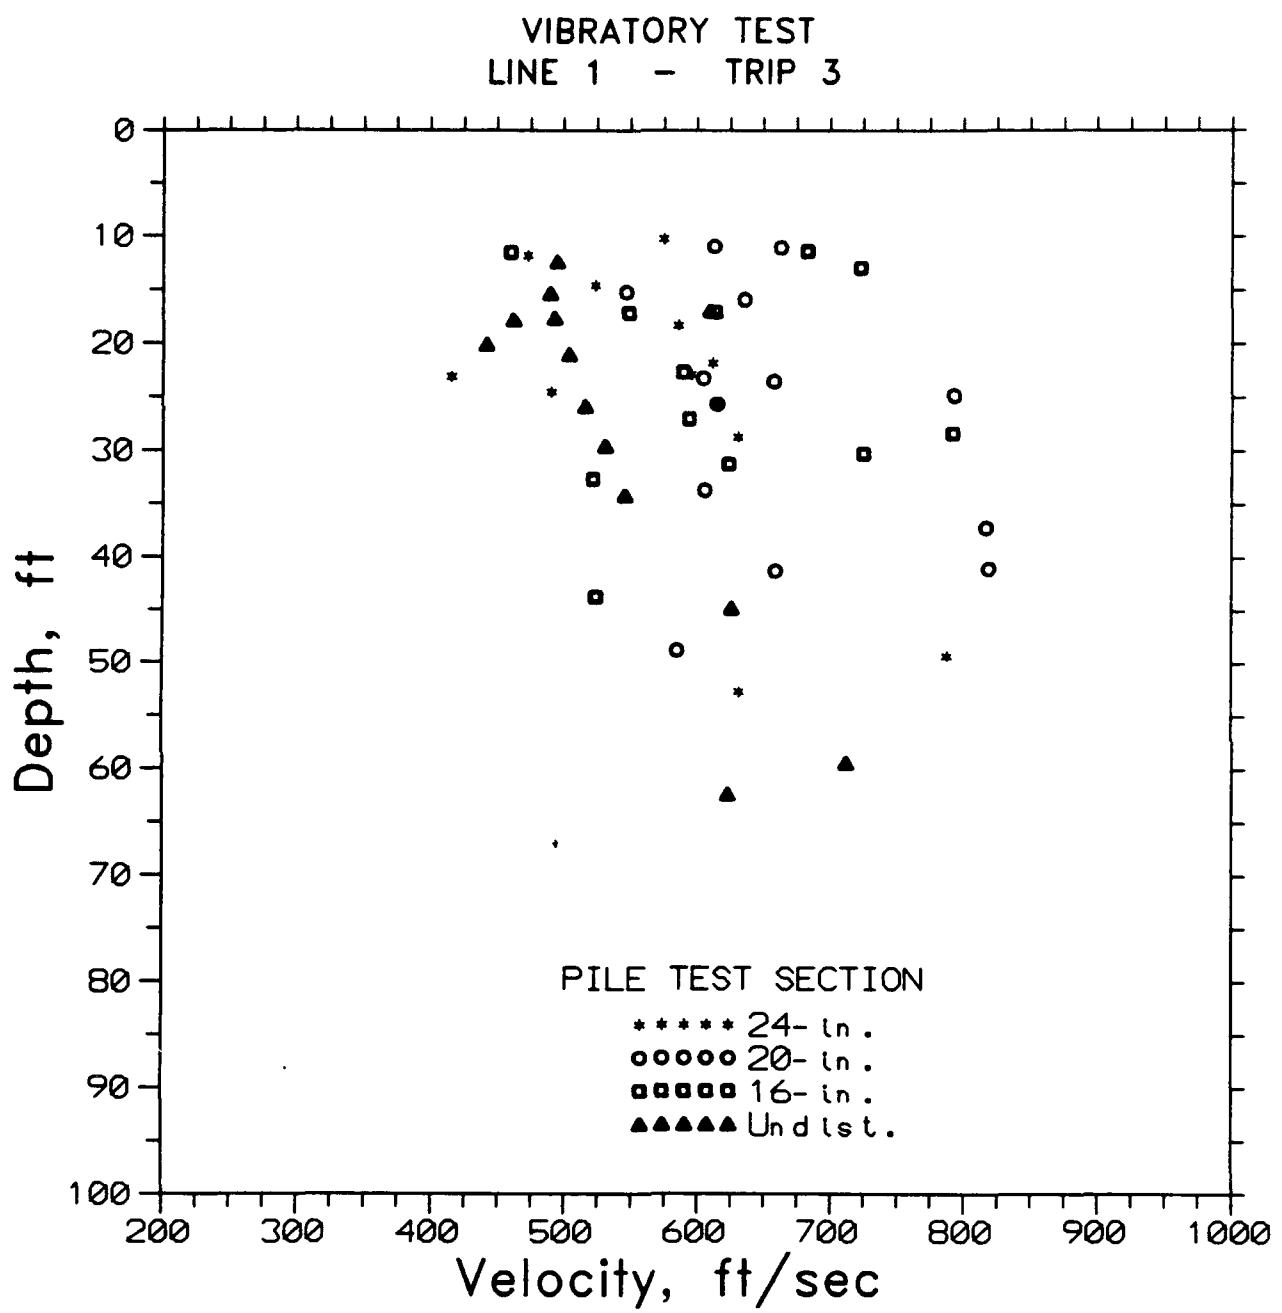
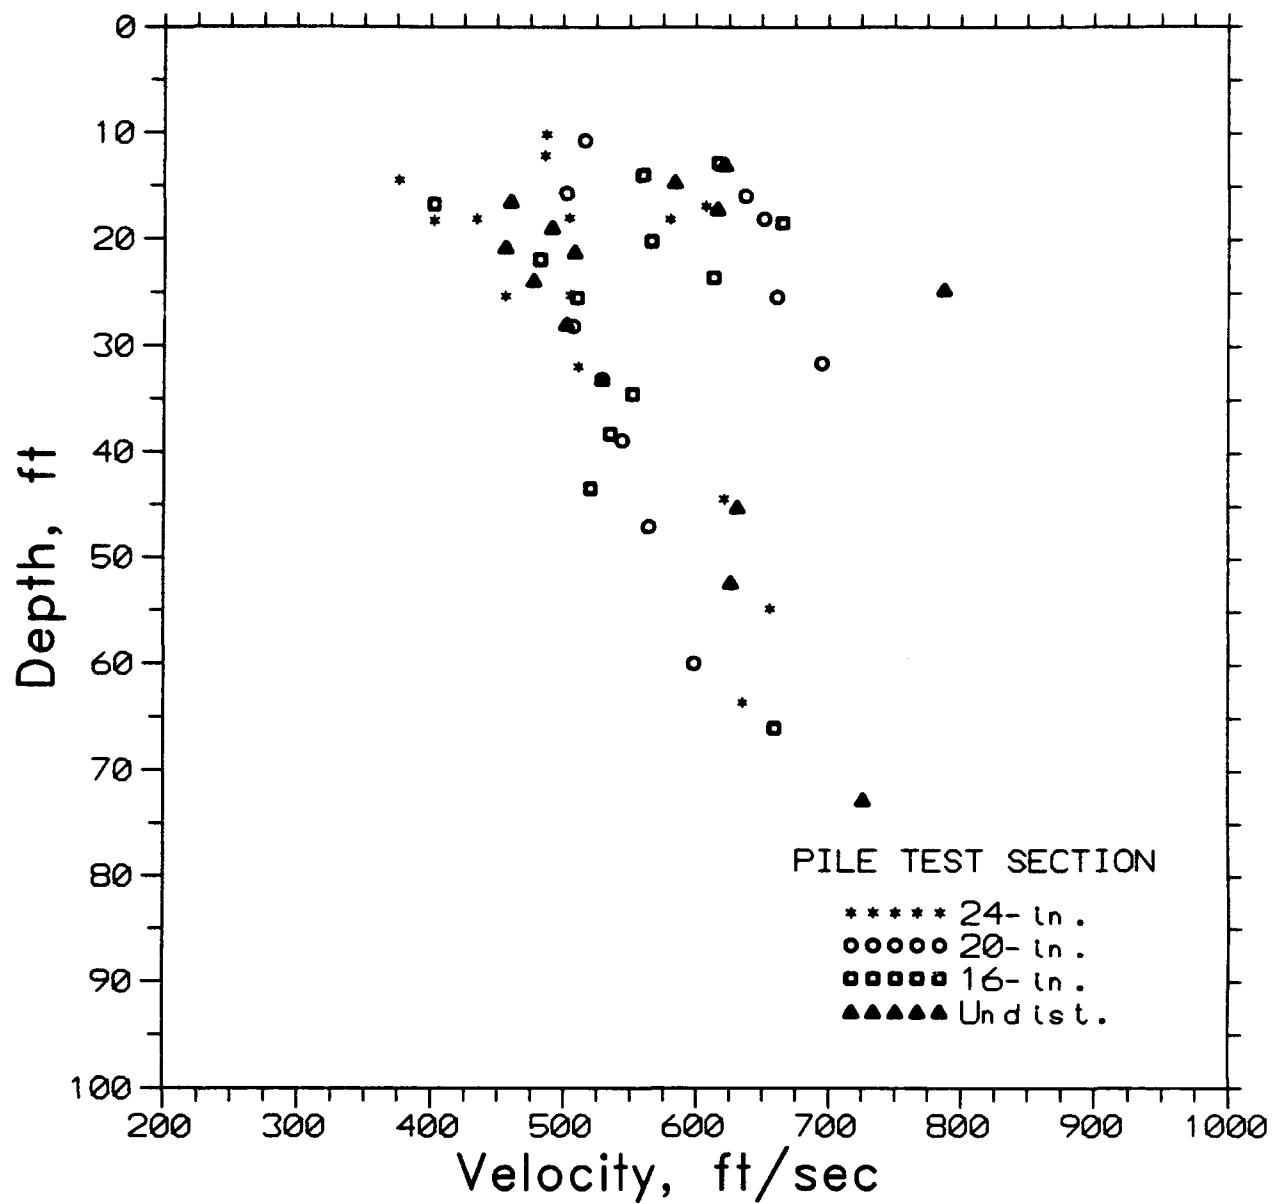
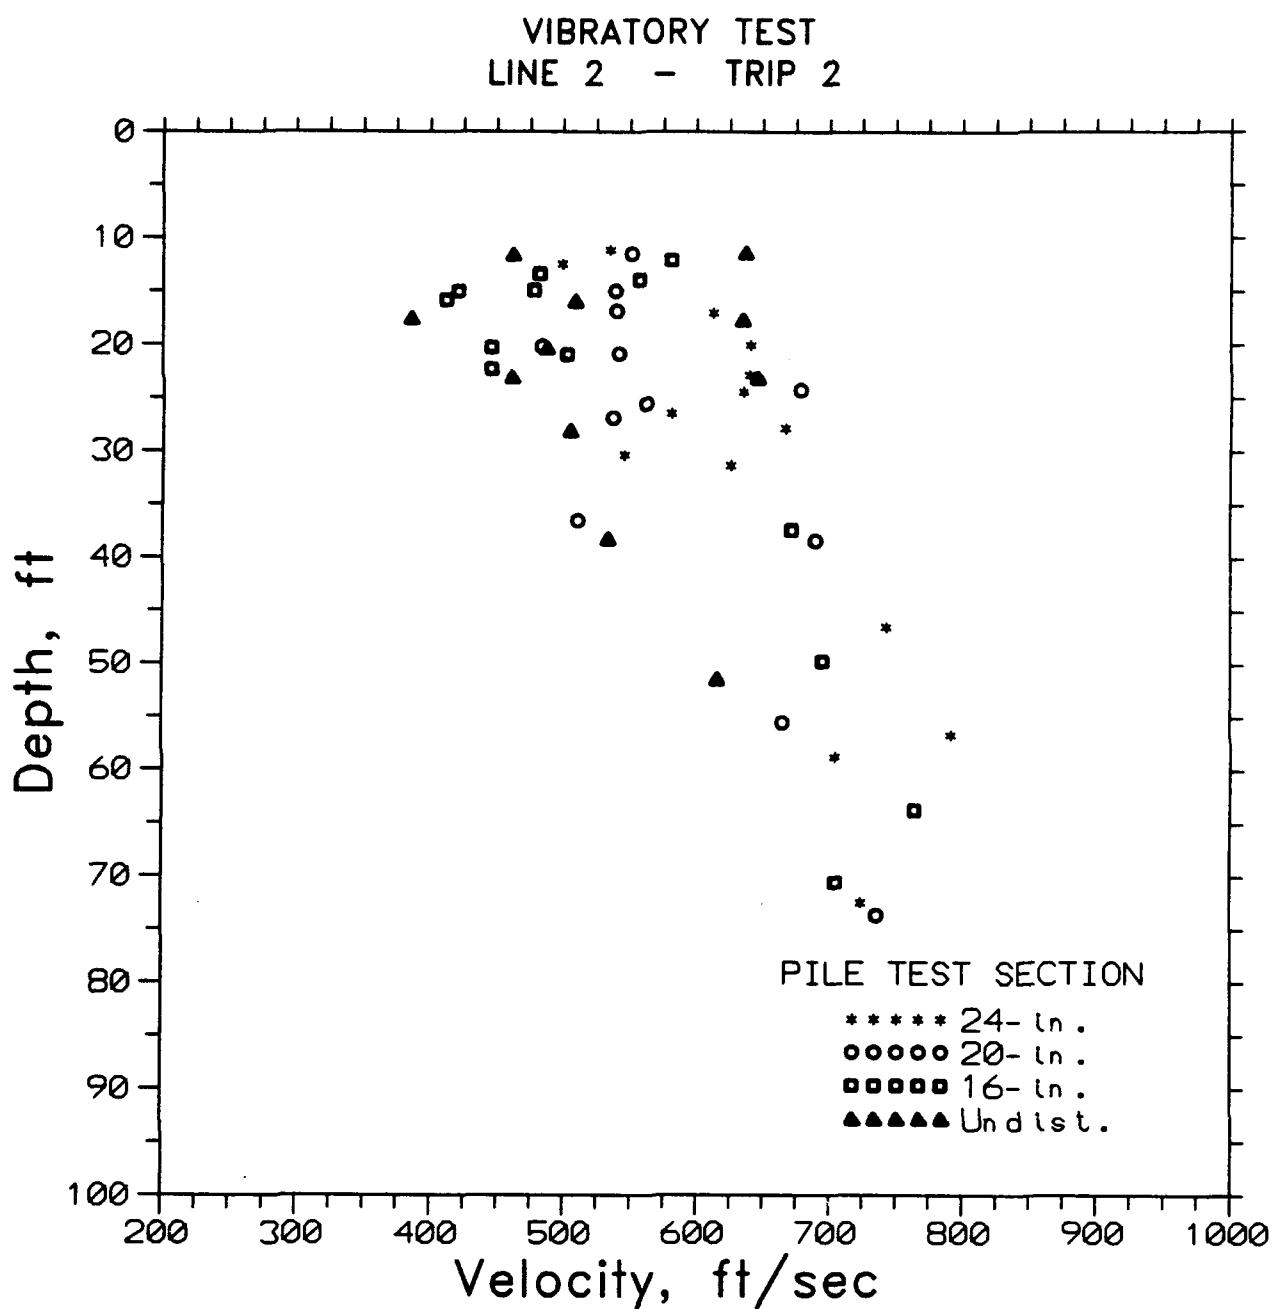
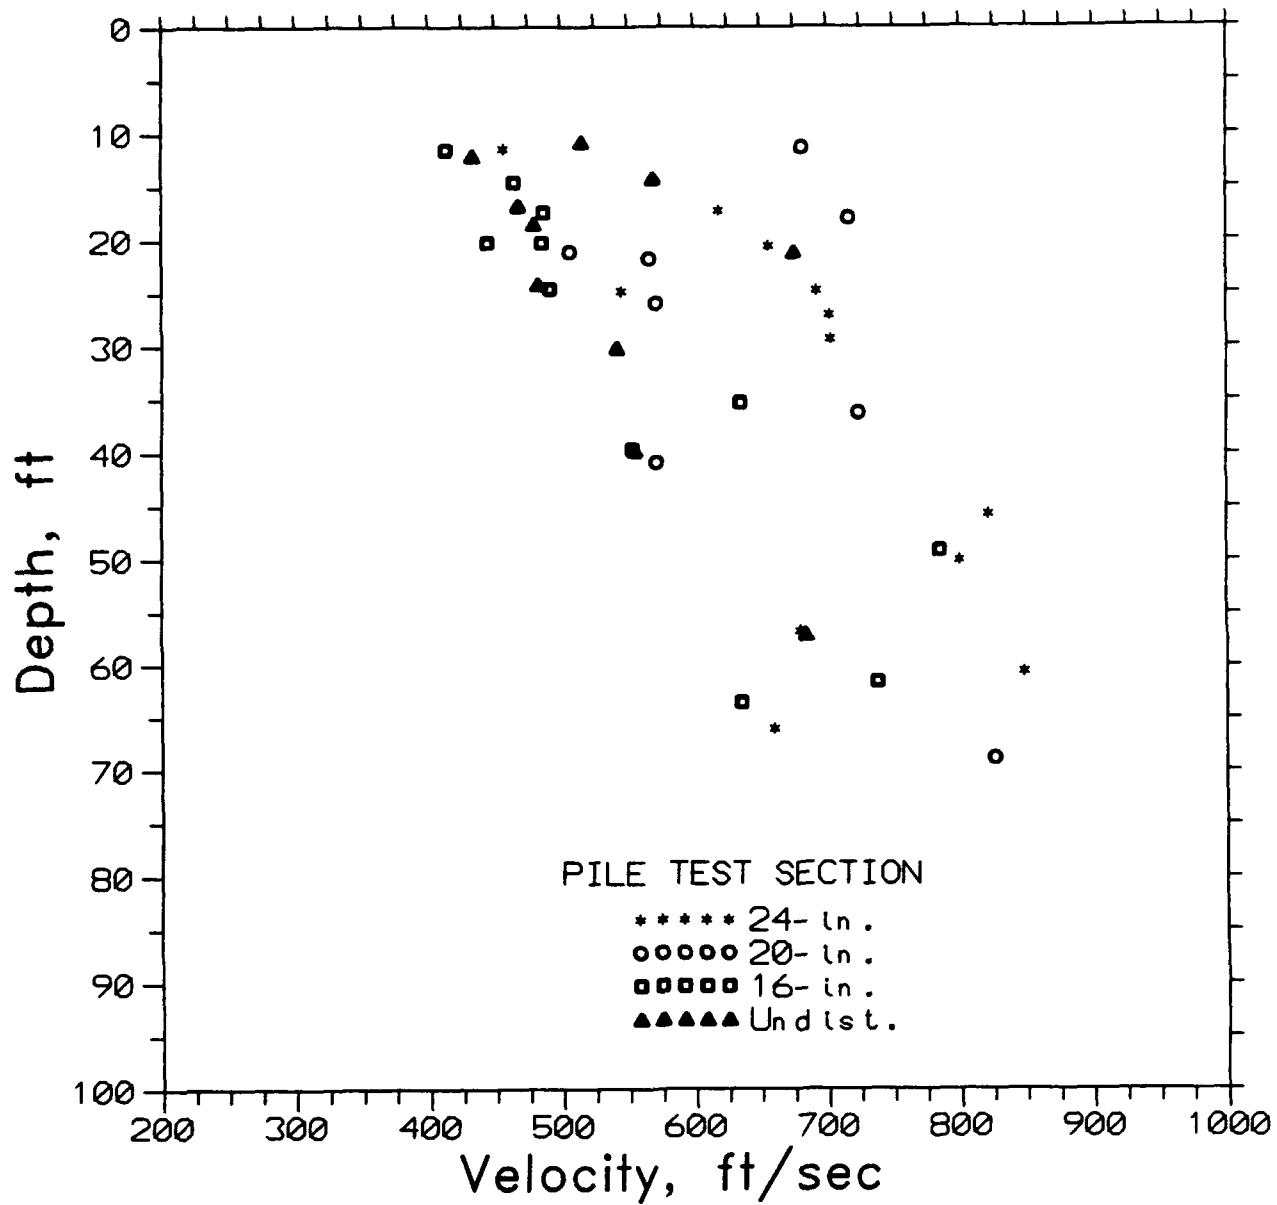
Figure 43. R-wave velocity versus depth, Line 1, Trip 1, pile test sections A, B, C, and background

Figure 44. R-wave velocity versus depth, Line 1, Trip 2, pile test sections A, B, C, and background

Figure 45. R-wave velocity versus depth, Line 1, Trip 3, pile test sections A, B, C, and background

Figure 46. R-wave velocity versus depth, Line 2, Trip 1, pile test sections A, B, C, and background

Figure 47. R-wave velocity versus depth, Line 2, Trip 2, pile test sections A, B, C, and background

Figure 48. R-wave velocity versus depth, Line 2, Trip 3, pile test sections A, B, C, and background

Using the same ANOVA method employed above, vibratory Lines 1 and 2 were analyzed to determine how the R-wave velocity differed as it traveled across the different test sections and background materials for a given trip. The velocity versus depth plots for Lines 1 and 2 are presented in Figures 43 through 49. The results of the analysis are presented in Table 3.
